AAC Publications

Fall on Rock, Protection Pulled Out, Inadequate Belay

Colorado, Boulder Canyon

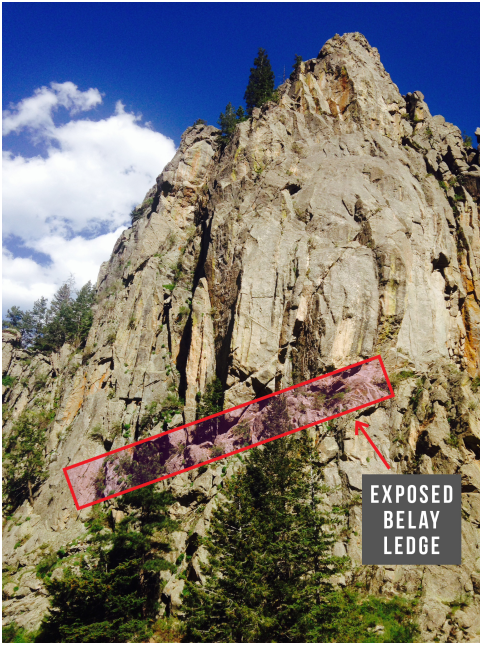
Many of the climbs on Bell Buttress start from a narrow ramp that traverses the cliff above a lower rock band. Although climbers often choose to belay with no bottom anchor on this ledge, this incident clearly demonstrates why a secure anchor must be established anytime the belay stance is exposed. (Source: Aram Attarian.)

Bell Butress, in Boulder Canyon, where many routes begin from a narrow ramp that traverses the cliff 100' above the base.
