### **Fall on Rock - Rope Severed on Sharp Edge, Inadequate Protection**

Minnesota, Sandstone ice cliff

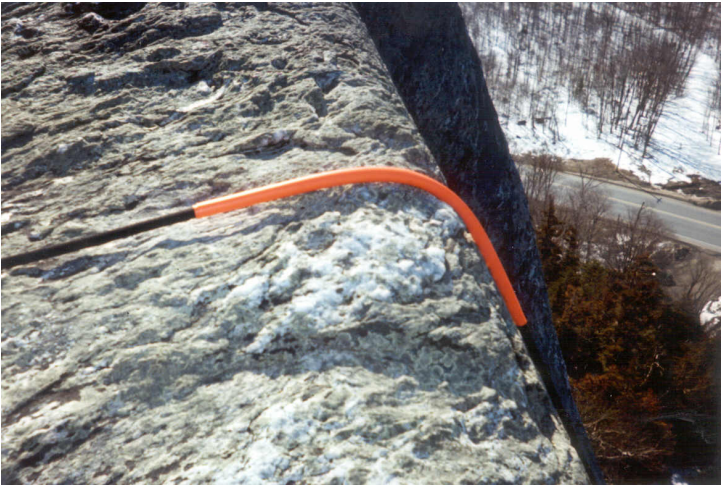
Example of rope protection for an anchor or top-rope.

This accident might have been prevented by the use of edge protectors, a better understanding of the type of rock and its susceptibility to erosion and sharpness, an anchor system that extended over the sharp edge, a more thorough inspection for sharp or rough edges, and less horizontal movement while on rappel. (Source: Kathleen Loughran, 22.)
