## **Lowering Error – Poor Position**

California, Mickey's Beach, The Egg

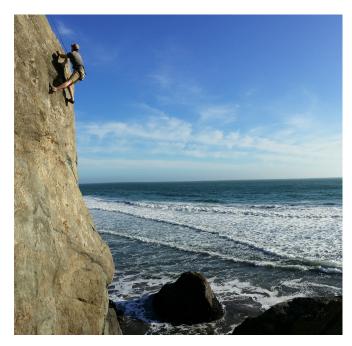
The fateful shot that led to the author's big swing.

There's plenty of danger to be found in climbing if you're careless. I should have considered my position while belaying as carefully as I do when I'm climbing. (Source: Brian Degenhardt.)
