Fall On Rock, Bolt Failure – Rope Soloing

California, Owens River Gorge

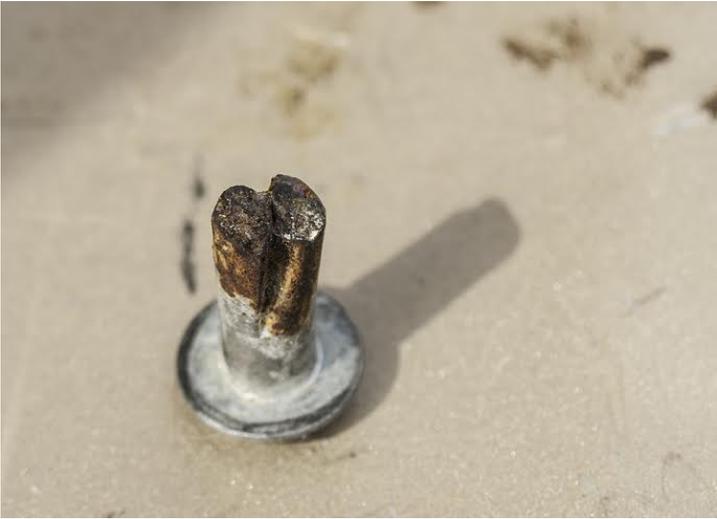
The bolt in question was not a standard 3/8-inch, five-piece expansion bolt; rather, it was a 5/16-inch buttonhead bolt (a pound-in compression bolt). The buttonhead bolt snapped approximately half an inch into its hole. Inspection of the bolt revealed corrosion below the surface and that the bolt may have been fractured prior to the accident.

While most modern five-piece and glue-in style bolts are strong and reliable (when placed correctly in good rock), climbers should be suspect of any older bolts, which are often not drilled deeply. Age greatly affects the integrity of most bolts; this one was likely placed on the first ascent, over 20 years ago.

The fractured third bolt from Life in Electric Larvae Land. Note the corrosion below the surface of the bolt head.

The climber could have prevented this accident by implementing some form of redundancy (clipping into more than one bolt) or a true self-belay (utilizing an anchor near the ground) into his rope-solo system. Instead, he put his faith in single points of protection, well off the ground. It's impossible to say if a helmet would have saved Sederstrom after falling from such a height. (Source: The Editors.)

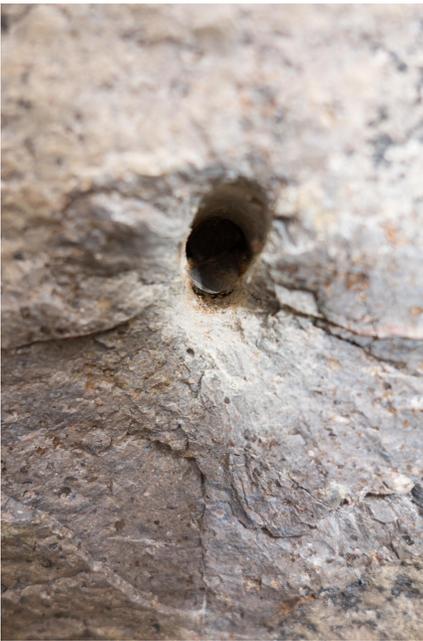
The third bolt hole on Life in Electric Larvae Land. The rear half of the bolt can still be seen embedded in the rock. The rock scarring below the hole is likely at least partially from the installation of the bolt, but may have been enlarged during the bolt failure.
