AAC Publications

Fall on Snow

Alaska, Denali, West Buttress

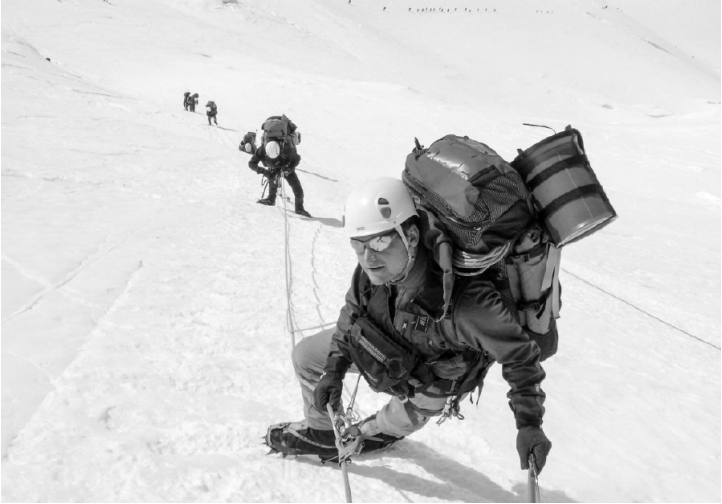
When moving up or down the fixed lines on Denali's West Buttress, climbers should stay about 10 to 12 meters apart and use the lines only for balance.
