AAC Publications

Fall on Rock

Arizona, Sedona Area, Oak Creek Spire

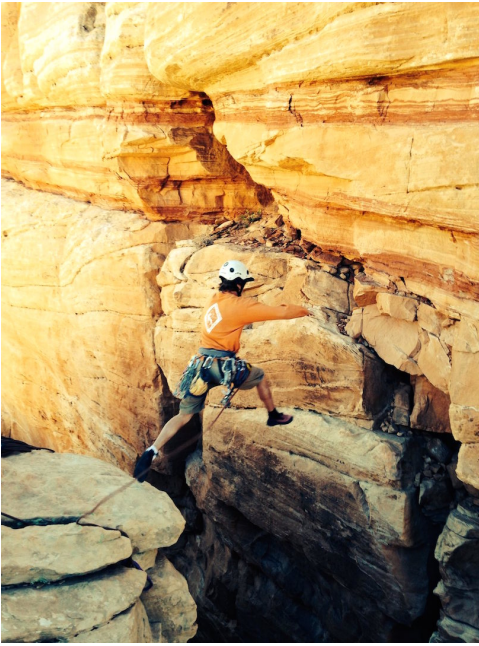
A climber successfully making the jump move to start the third pitch of Oak Creek Spire, AZ.

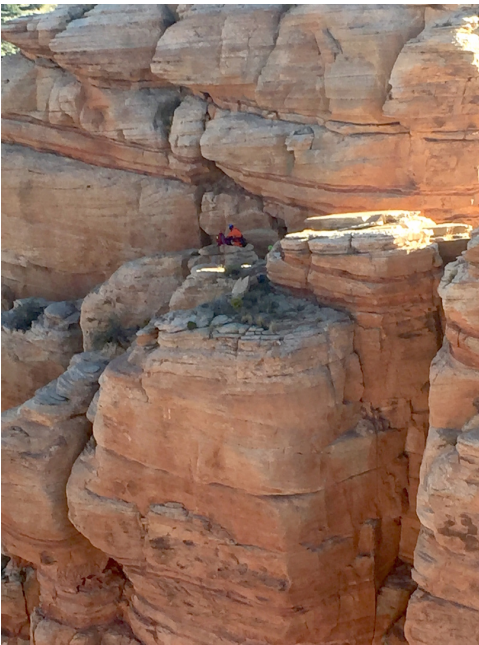
Climbers awaiting rescue on Oak Creek Spire.

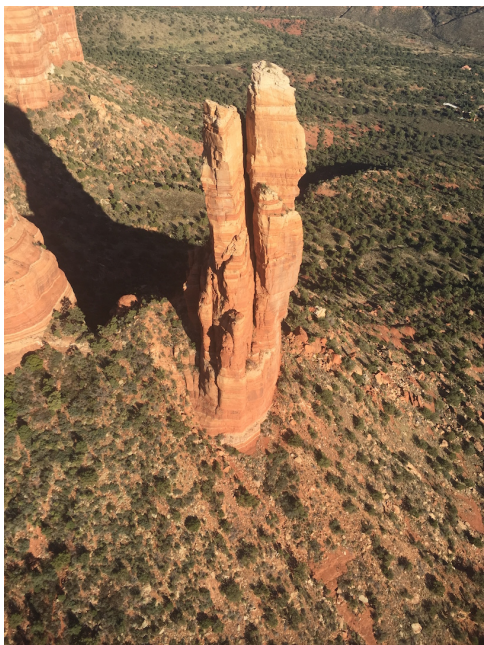
Oak Creek Spire from the air, clearly showing the lower and higher summits.
