Rockfall

Wyoming, Middle Teton, Dike Route

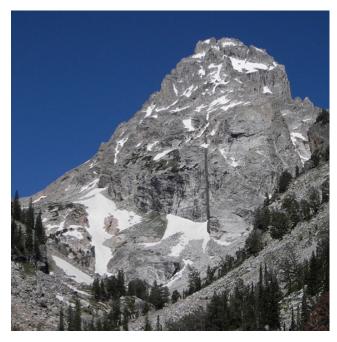
The Middle Teton (12,805 feet), with the Black Dike prominent in center and the South Fork of Garnet Canyon to the left. NPS Photo
