### **Leader Fall – Protection Pulled Out**

California, Yosemite Valley, Washington Column

Author	Yosemite National Park Climbing Rangers
Publication	ANAM
Volume	11
Issue	70
Page	46
Copyright Date	2017
Article Type	Accident reports

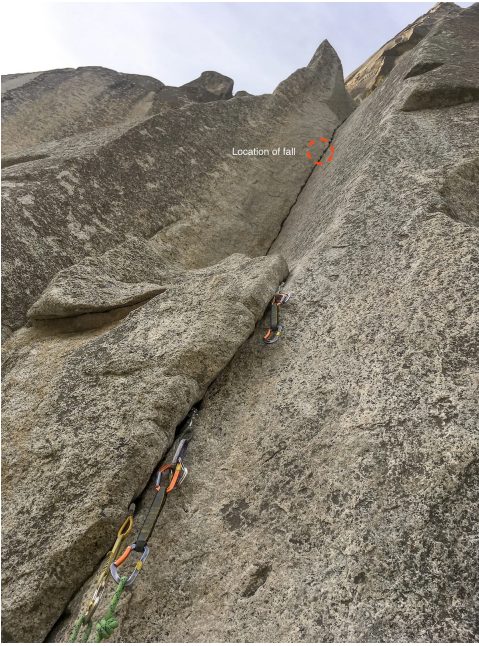
First climbed in 1964, the crack systems of the South Face Route were heavily scarred by repeated piton placements. The typically shallow and flaring nature of these features can make protection in them less secure and harder to gauge than a normal crack placement. Seeing the inverted lobes on the first cam that pulled out, our best guess is that the cam failed because it was either under-cammed (piece too small for the placement) or placed in a flare.

Although it's impossible to know for sure, we also speculate that Mike placed the cam straight in as opposed to angling downward in the direction of the anticipated pull, because only two lobes of the cam were damaged. A cam placed straight in will distribute a disproportionate amount of force to the upper lobes, in this case possibly resulting in their failure.

The leader had placed a piece but not yet clipped it when the cam he was standing on pulled.

In overhanging terrain, Mike's fall might have ended up fine. But when climbing above ledges or in low-angle terrain, place solid gear early and often. (Source: Yosemite National Park Climbing Rangers.)
