Rappel Error – Water Knot in Anchor Tether Came Untied

Wyoming, Grand Teton, Owen-Spalding Rappel

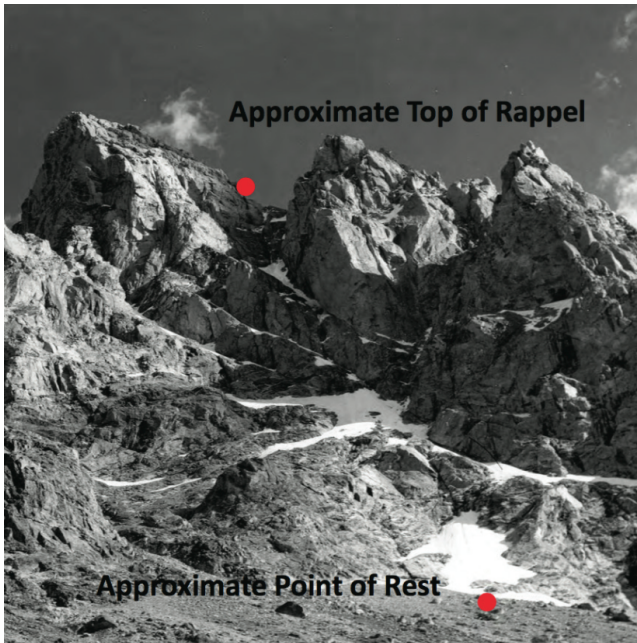
The Grand Teton from Valhalla Canyon, showing the long fall suffered by a mountain guide when his anchor tether failed at the top of the Owen- Spalding rappel.

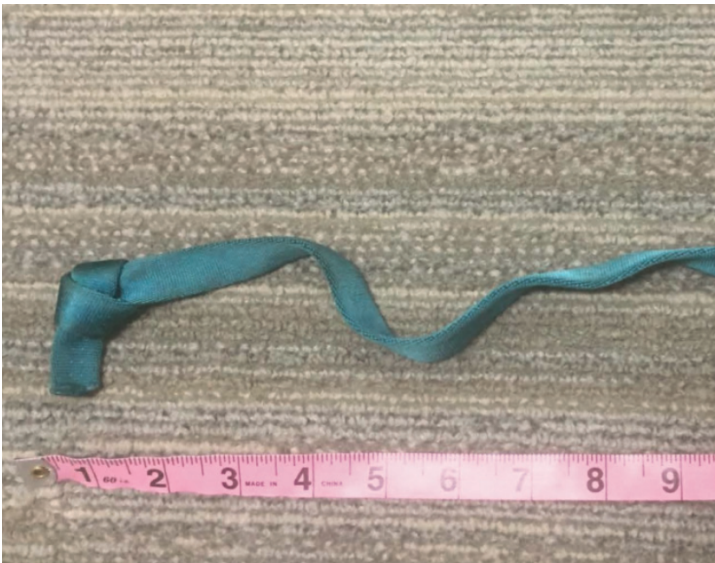
Numerous witnesses stated that the guide was secured to the anchor prior to the fall. Several of the witnesses noted that he was, at times, weighting the lanyard. After the fall, a 98-inch section of blue 9/16-inch tubular webbing was found entwined in his harness. An overhand knot was found in one end of the webbing. A photo taken prior to the technical portion of the climb shows that this webbing was tied in a loop with a water knot. One tail is visible and is of adequate length, but the knot is not tightened.

All the evidence leads to the conclusion that the guide was tethered to the anchor with webbing that was tied in a loop with a water knot, that one of the tails on the knot was of inadequate length, that the tail slipped through the knot, causing it to fail while he was weighting the lanyard, and that this caused him to fall from the rappel stance. (Source: National Park Service Search and Rescue Report.)

A 9/16-inch sling with an overhand knot, found with the climbing guide who fell from the Owen-Spalding rappel on the Grand Teton. Investigators concluded this sling, used to tether the guide at the rappel anchor, had been tied with a water knot that came undone under load.

EDITOR'S NOTE: A water knot should be tied with both tails protruding from the knot at least three inches, and the knot must be retightened periodically. This tragic death of a professional guide reminds
