AAC Publications

Ground Fall – Fixed Quickdraws Broke

California, Owens River Gorge

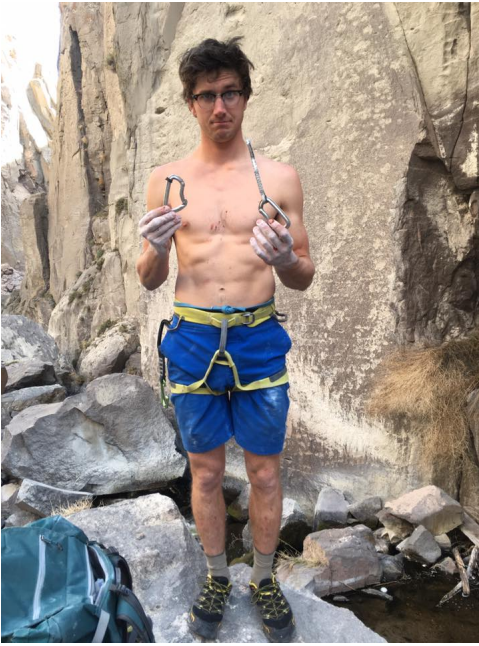
The hazards of fixed quickdraws are well-established. These quickdraws had been in place for about a year. The webbing on one of them broke at the upper carabiner (bolt end) and the other at the rope end. This climb receives little to no sun, but wind in the gorge likely caused the quickdraws to swing back and forth, abrading the webbing. Cannon said he did not see any damage to the draws, but the abrasion could have been hidden on the inside of the webbing. Fixed quickdraws of all kinds (including steel "perma-draws") also may develop worn grooves or burrs in the rope-end carabiner, which can shred or even cut a rope.

Jordan Cannon holds the remnants of two quickdraws that broke when he fell past them in the Owens River Gorge.

Fixed draws are convenient—and may be unavoidable on some climbs—but climbers should try to inspect them before attempting a route and consider replacing or supplementing them with their own quickdraws. Cannon was lucky to avoid more serious injury—this is a good example of the value of wearing helmets even on "well-protected" sport climbs. (Sources: Jordan Cannon and the Editors.)

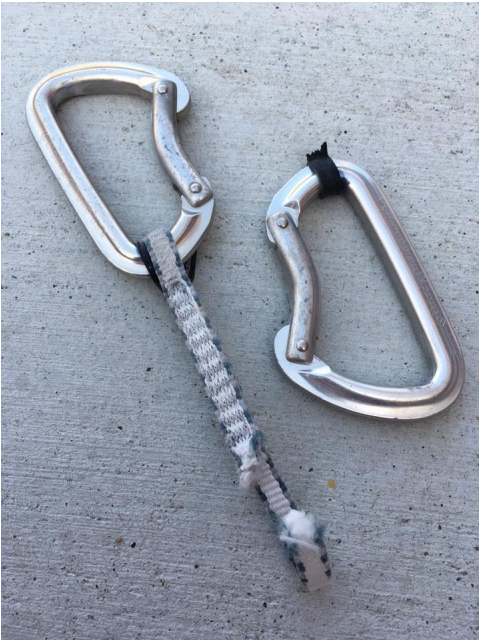
Two broken quickdraws that had been fixed on Bongo Fury in the Owens River Gorge and broke as a result of a climber's fall.
