### **Lowering Error – Inexperience**

California, Mammoth Lakes, Clark Canyon, Area 13

Author	
Publication	ANAM
Volume	11
Issue	71
Page	52
Copyright Date	2018
Article Type	Accident reports

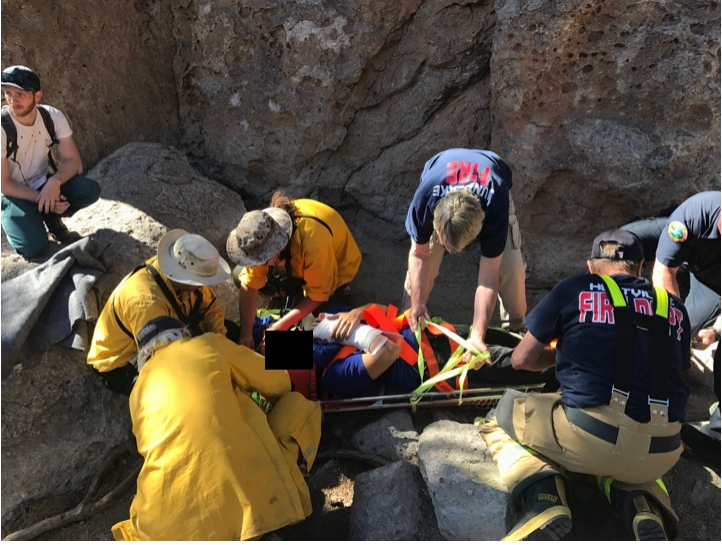
Rescuers on scene after a ground fall in Clark Canyon.
