## AAC Publications

### Fall on Rock – Loose Rock

Alaska, Lake Clark National Park, Hidden Mountains

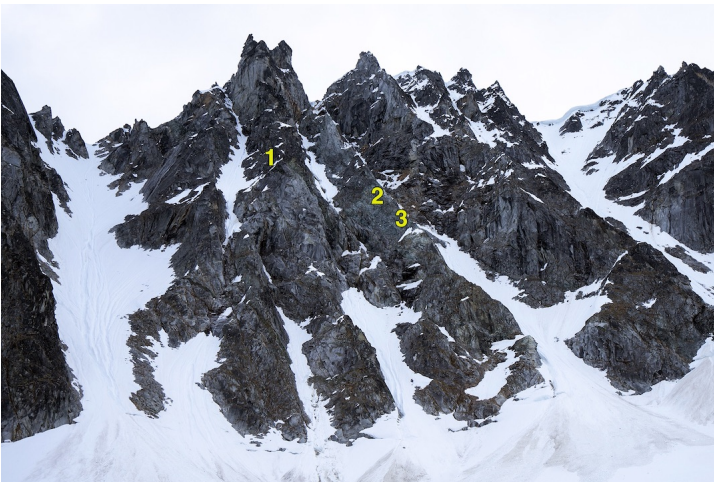
The injured climber had placed adequate gear (approximately 10 pieces in 150 feet), and his fall was arrested by the last piece he placed (a medium-sized nut). The fall distance was 20 to 30 feet. He was climbing within his technical ability and was wearing a helmet, which was lost when he received trauma to the head.

We believe that loose rock was responsible for the accident. Emmett likely weighted a loose or broken block, which in turn dislodged other rocks while also causing him to fall. A similar accident might be avoided by selecting objectives with high-quality rock or by retreating when loose rock is encountered.

The accident scene on an unnamed peak in the Hidden Mountains of Alaska. (1) Location of John and Alissa at the time of the fall. (2) Emmett's position. (3) Emmett's belayer. The face is about 1,500 feet high.
