Fall On Rock – Downclimbing Fourth-Class Terrain

California, Sierra Nevada, Palisades, Thunderbolt Peak

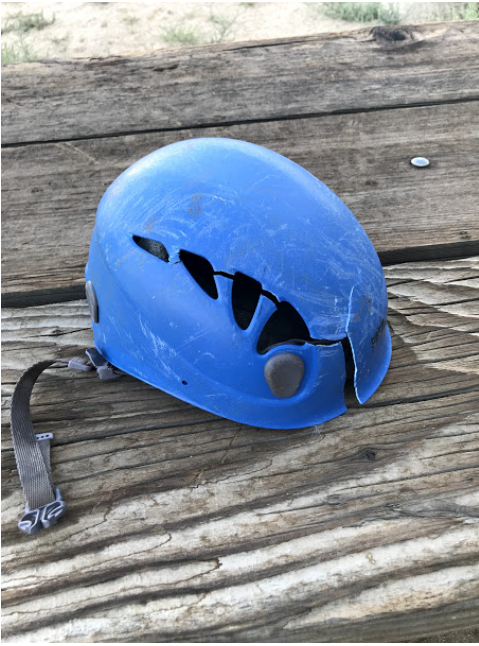
Climber's smashed helmet after a long tumble in the North Couloir of Thunderbolt Peak.
