AAC Publications

Ground Fall – Inexperience, Inadequate Belay

North Carolina, Pilot Mountain State Park, The Parking Lot

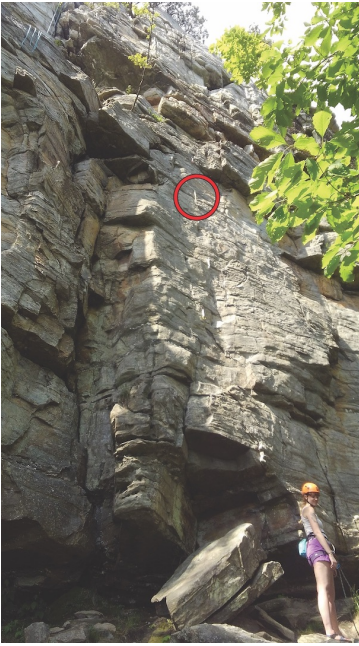
Late in the afternoon on May 9, Dylan Pappas (21) fell to the ground while climbing Chicken Bone (5.8), a ten-bolt sport route. A member of his climbing party had led the climb before him and left the draws in place. The third bolt was clipped with a shortened sling (an “alpine draw”), with which Dylan had no experience. A witness stated that while attempting to clip this draw, about 25 feet up, it appeared Dylan was “fiddling with his sling and carabiner.” He accidentally removed the lower carabiner from the sling and then, when he attempted to reclip it, he did so incorrectly. When Dylan weighted the rope, the lower carabiner pulled free from the sling.

When used properly, extendable slings can reduce rope drag and minimize the chance of traditional protection pieces pulling out. In this case, the sling was configured properly but used incorrectly by Dylan. Additionally, the belay was inadequate. Had the belayer been paying closer attention, he may have had time to lock off the brake strand before the climber hit the ground. (Source: Aram Attarian.)

A climber (unrelated to this incident) below Chicken Bone at Pilot Mountain, showing the bolt where another climber incorrectly clipped a quickdraw and then fell to the ground.
