AAC Publications

Avalanche – Poor Position, Weather

Canada, British Columbia, Mt. Robson Provincial Park, Whitehorn Mountain

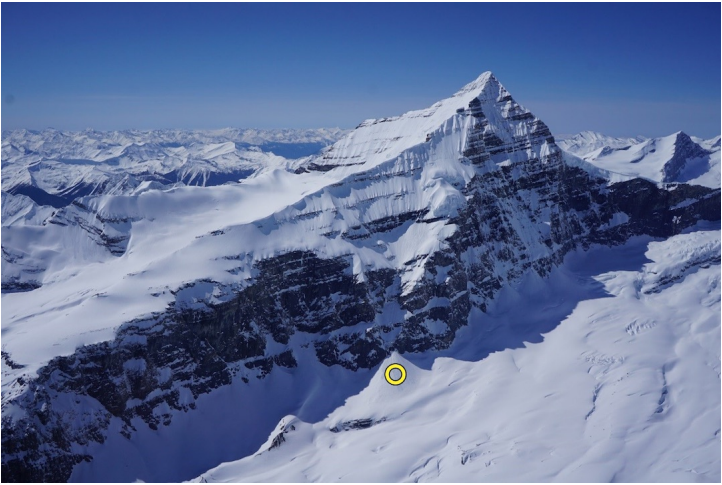
Location of the fallen climbers after an avalanche on Whitehorn Mountain. The two were most of the way up the prominent rock band directly above the debris fan when the avalanche swept them off.

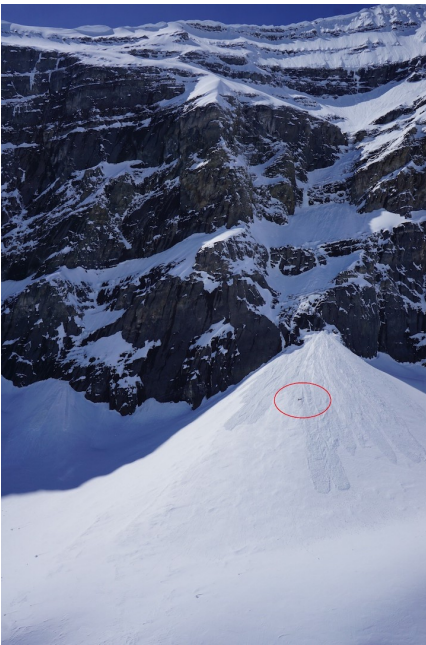
Location of two climbers in the debris fan below the northeast face of Whitehorn Mountain after an avalanche swept them from the route.
