### Rappel Anchor Failure

Alaska, Juneau Icefield, Mendenhall Towers

Author	Climber 1
Publication	ANAM
Volume	12
Issue	73
Page	26
Copyright Date	2020
Article Type	Accident reports

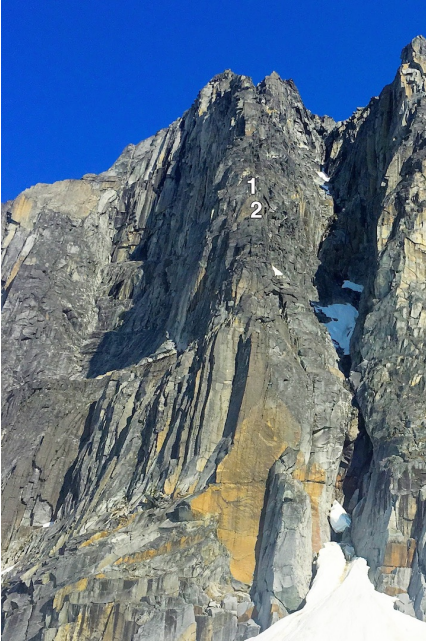
The rappel anchor at the large ledge was one bomber large hex and one medium wire, poorly equalized with a cord and a quick-link at the masterpoint. A visual inspection revealed that one end of the cord was frayed and without much space between the knot and the fraying end; Climber 1 also noted the anchor cord was the same as he had seen on this anchor the year prior. After a short discussion, the climbers concluded the anchor was good enough. The party began rappelling without replacing the cord or backing up the anchor.

Climber 1 started down, and in an effort to save time he bypassed the next spacious ledge, about 40 feet below, and continued down the ridge on rappel to a small ledge, descending a total of about 100 feet. He found a suitable horn to sling and went off rappel. Climber 2 rigged his rappel device, walked from the anchor to the lip of the ledge (15 feet), weighted the rope, and instantly the anchor failed. Climber 2 fell to the next ledge 40 feet below, taking the rappel rope with him in his fall. Climber 1, down below, did not witness the fall, only heard a very loud thud. Climber 3 witnessed the anchor failure: Both pieces of rock protection were still in the wall, but the cord that had connected the pieces was at his feet.

The party's decision not to replace the old tat on the rappel anchor proved to be a fatal mistake. This decision was made in a very fatigued state, and the climbers' judgements were impaired. They prioritized getting back to base camp quickly over taking extra time to ensure the safety of their anchors. This seems like a very misguided error, but in the early hours of the morning, running on little sleep, dehydrated and hungry, you may make odd decisions you would not otherwise.

Southeast buttress of Main Tower in the Mendenhall Towers. (1) Location of rappel anchor that failed. (2) Ledge where rappeller landed after anchor failure and eventually was rescued by helicopter.

In addition to replacing or supplementing the old tat on the anchor, the climbers could have backed up each of their anchors while the first two climbers were rappelling. The third and lightest person to rappel could have removed the backups before starting down.
