## Ground Fall – Inadequate Protection

Colorado, Boulder Canyon, Castle Rock

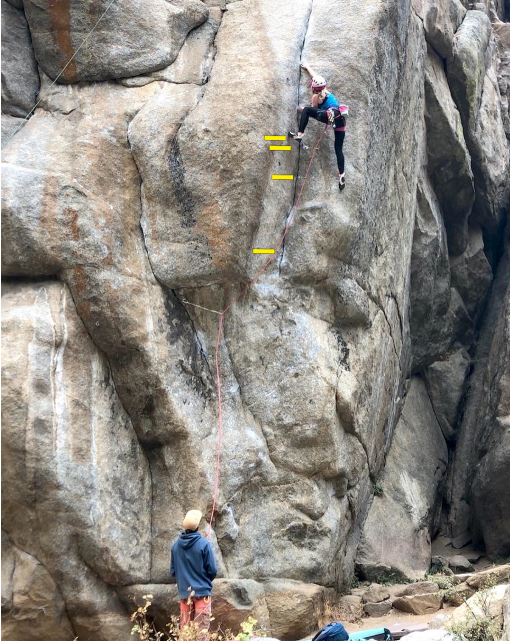
Molly got through the crux and fell after her foot slipped about 25 to 30 feet up. The fall ripped out four of the pieces of gear she placed, and she decked. (The gear that pulled out of the crack—from top to bottom—included a small RP nut, a purple Totem Cam, a small offset nut, and a medium-size nut.) Fortunately, she landed on a bouldering pad that she and her partner had laid out for the lower section, just in case. Nonetheless, she ended up with compression fractures in her L2 and L3 vertebrae. No surgery was needed because nothing was displaced, but she had to wear a back brace for nine weeks.

After thinking about this a lot and watching the video of the attempt (which will eventually be released), I believe that even though I had tested some of the pieces of gear before, by falling onto the gear with the bolts clipped as backup, the rope was running in a different spot during my trad attempt. The pro was in two separate cracks and the rope was not in a straight line. So that was one factor.

Also, the crack is very polished, shallow, and flaring. The pieces are incredibly specific, and sometimes even when they look OK, they will not hold a dynamic fall. The bottom piece that pulled out (the medium nut) was a solid piece of gear, but what happened—and what you will eventually see in the video—is the tension in the rope from ripping the upper pieces actually lifted this nut up and out of the crack. Had that nut held, I would not have hit the ground.

Molly Mitchell attempting Crank It with traditional protection. The four pieces that pulled out in her fall are marked. The lowest of these was a good nut, but the action of the rope during the fall apparently levered it out.

I believed I had taken my time while rehearsing for this attempt and tried to figure out the gear. I had had a near-decking incident at the same spot a week prior, on gear that I had tested yet still ripped, and this made me fully reanalyze my gear for that section. I thought it was better, but obviously I did not account for the rope position, the nut lifting out, and the fact that if you don't place those pieces perfectly on the go, they will not hold - slippery, cryptic granite! I think potentially a double rope system, anchoring down the lower nut so it wouldn't get pulled out, and making sure to really place each piece perfectly would have helped.
