### Leader Fall — Protection Pulled Out

Canada, Alberta, Banff National Park, Mt. Louis

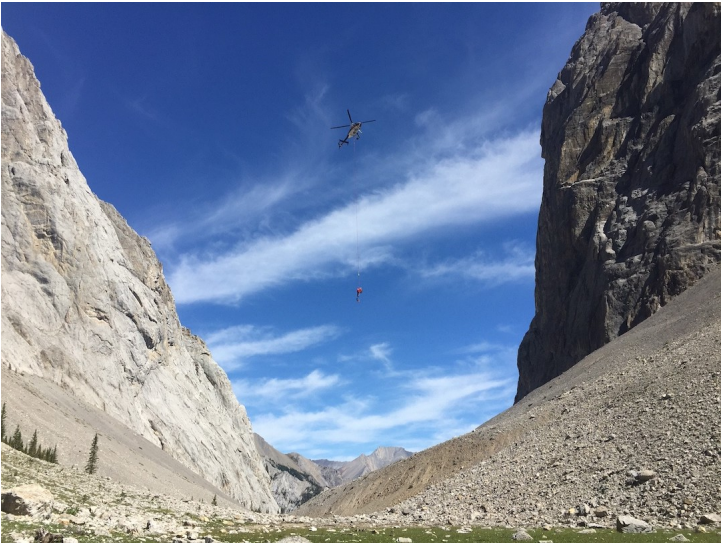
Helicopter slinging injured climber to a staging area in the Gargoyle Valley between Mt. Louis and Mt. Edith.
