Leader Fall — Loose Rock, No Belay, Possible Haste

Canada, Alberta, Banff National Park, Mt. Rundle Traverse

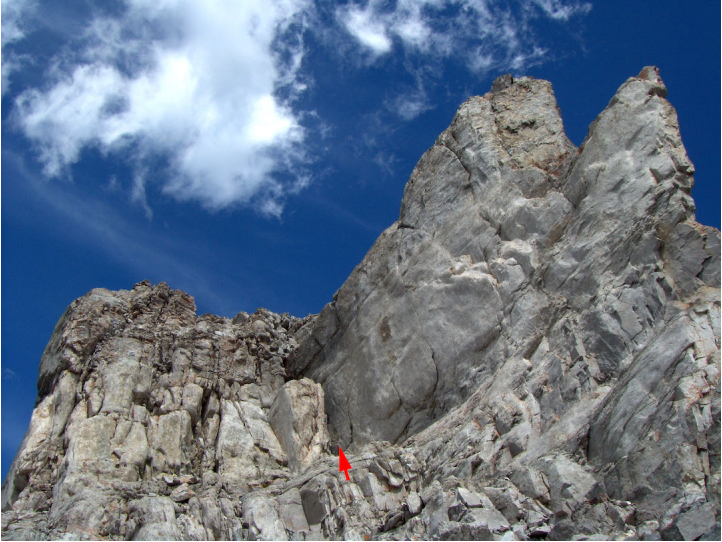
In the afternoon, the party reached Peak 10, which has a short chimney climb right below its summit. At this rock step, one of the party members (E.M.) wanted a belay. A.S. offered to drag a rope up to the top, set up an anchor, and belay E.M. up. A.S. was about 20 meters up, comfortably climbing the chimney, when a foothold broke and the climber fell to the ledge below, breaking one lower leg. A.S. was not on belay at the time of the fall, so E.M. pulled in the slack and wrapped the rope around her hands. This makeshift belay and the rope running around a large, loose boulder blocked A.S. from tumbling further down the west side of Mt. Rundle.

Loose rock is common in the Rockies. Carefully selecting and testing handholds and footholds is a common strategy to prevent a fall. The consequences of the fall may have been minimized if the lead climber had been belayed and was able to place protection. Likely, the desire to move quickly through this passage, with another technical peak and a long descent still to go, contributed to the decision to climb unbelayed. (Source: Banff, Yoho & Kootenay National Parks Visitor Safety Team.)

Peak 10 of the Rundle Traverse, showing the chimney where a climber fell.
