Rockfall — Poor Position

Canada, Alberta, Bow Valley, Grotto Mountain

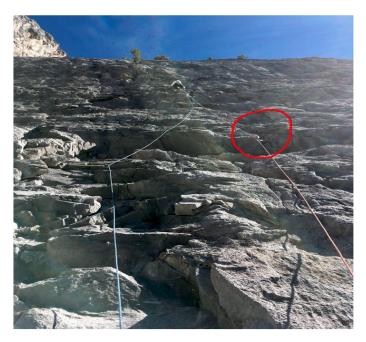
When Tibor was approximately 40 meters up, he stepped on a ledge that failed, resulting in significant rockfall. Several pieces the size of bread loaves bounded down the face and directly onto my exposed belay stance. Fortunately, I was hit only by five smaller rocks, which resulted in various flesh wounds. We rappelled off, patched a bleeding leg wound with a gauze pad and duct tape, and walked back to the car under our own steam. In retrospect, I was just plain lucky. Although I was wearing a helmet, a direct head hit by one of the big rocks likely would have been fatal.

We got into trouble because we did not consider my belay stance's exposure to potential rockfall. If we had relocated the belay for the second pitch to the well-protected alcove I had used before, I would not have been injured by the rockfall.

The new bolts that I mistakenly took to be the belay station for the second pitch may have been placed for rappelling the route. The walk-off from this route is tedious, so rapping to descend has definite appeal. But this new station is exposed to rockfall for anyone who rappels the route or chooses to belay from this spot.

The pitch on Jughaul Wall where a rockfall accident occurred. The red circle shows an alternate belay stance that might have been more protected from rockfall.

Ice climbers are very careful about where they set up belays, because falling ice is a given. From now on, I'll give a lot more thought to where I belay when rock climbing. (Source: Everett Fee.)
