Leader Fall – Belay Anchor Failure

Colorado, Eldorado Canyon State Park, Wind Tower

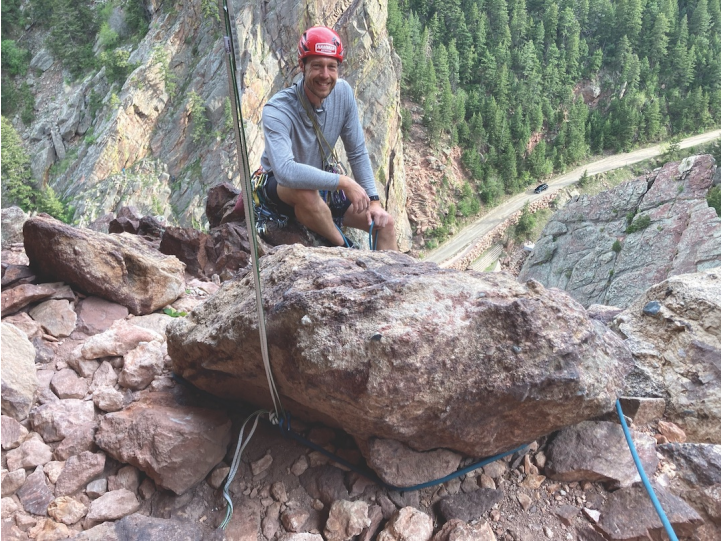
The second-pitch belay anchor on Wind Ridge is best built with this large block, in this case using part of the lead rope to tie it off. The long sling in the foreground is clipped to a cam placed in a shallow pocket.

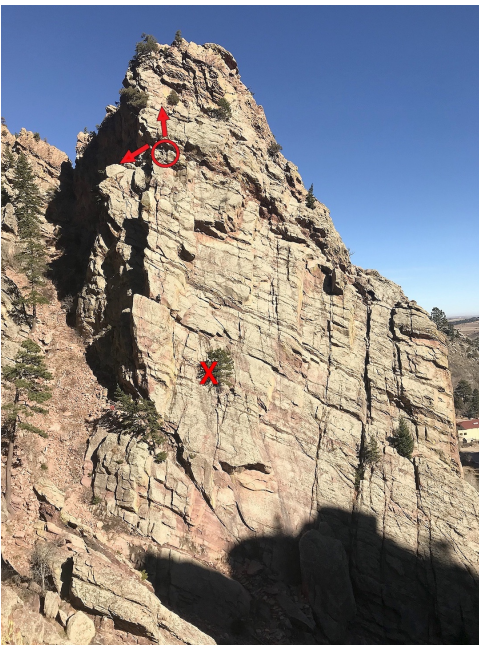
Runyon found no gear clipped to the rope between Climber 1 and Climber 2, indicating there may have been no intermediate protection between the two climbers at the moment of the fall. Later, SAR found no evidence of an anchor at the belay ledge. Perhaps the pair were unanchored. Perhaps their gear came unclipped or broke, as can happen in severe incidents. What is certain is their anchor, assuming they had one, was insufficient.

Wind Ridge climbs directly to the circled belay ledge atop pitch two. From here, climbers can either escape left or continue through an overhang. In this incident, two climbers fell all the way to the point marked X after their belay anchor failed at the circled ledge. One of them was fatally injured.
