AAC Publications

Ascending Error — System Failure

Oregon, Central Oregon, Steelhead Falls

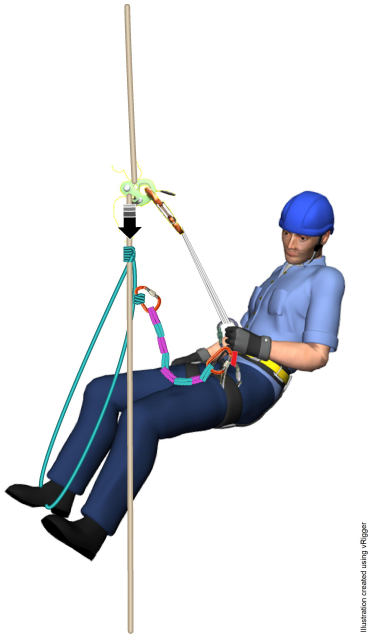
While ascending the rope, the subject's glove got caught on the exposed teeth of an Edelrid Spoc progress-capture pulley being used for ascension, while the climber was attempting to move it upward on the rope. As a result, the teeth of the progress-capture pulley failed to engage the rope and the pulley slid down the rope onto the subject's lower rope grab [the term for any device or hitch that travels on the rope and automatically engages to arrest a fall]. The lower rope grab consisted of a 5mm accessory cord configured as a foot loop and attached to the rope with a prusik hitch. This lower rope grab was connected to the subject's harness by a locking carabiner connected to an older model Metolius Ultimate Daisy Chain girth-hitched to their harness belay loop. The pulley collapsed and tended the prusik hitch (prevented the prusik from grabbing the rope) as it was weighted, resulting in loss of positive connection to the rope. The result was an uncontrolled fall to the ground.

The upper rope grab was defeated, fell down onto the lower rope grab (three-wrap prusik with 5mm accessory cord), and caused it to fail. A CMRU member was later able to re-create the cause of the accident using several combinations of progress-capture pulleys of various brands over friction hitches. It appears the cause of this accident was not directly associated with any particular brand of gear or type of friction hitch used, but rather the configuration of a "hard" rope grab over a "soft" rope grab.

A secondary cause of this incident was the climber's glove getting caught on the teeth of the upper ascender while manipulating the device, which may have prevented it from fully engaging the rope. The ascender was a pulley that was capable of overriding the prusik and breaking the friction grip of the hitch. One foot was on a ledge, partially supporting the climber's weight, and this may have made it harder to detect the initiation of the defeat of the upper ascender. By being only partially weighted (with some of the climber's weight being supported by the foot on a ledge) the grip of the lower prusik hitch may not have been solidly set and may have been looser around the rope than normal, allowing it to be broken more easily.

The climber's glove caught in the teeth of the progress-capture pulley, causing the device to slide down the rope.

As the progress-capture device slid onto the top of the prusik, it caused the hitch to fail and the climber slid down the rope to the ground.
