GROUND FALL – Leader Significantly Heavier than Belayer

New Mexico, Socorro Box Canyon

Author	Christian Sommer and The Editors
Publication	ANAM
Volume	13
Issue	76
Page	59
Copyright Date	2023
Article Type	Accident reports

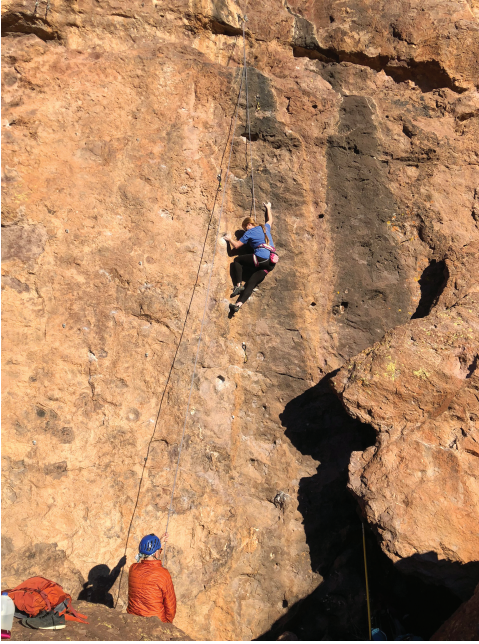
According to an eyewitness, Climber 1 outweighed the Belayer by approximately 65 pounds. Belayer had only a small “J” of slack present between themselves and the first bolt. There was about three feet of total slack in the rope.

The weight difference, the small bit of slack, and the fact the leader fell from the height of the not-yet-clipped third bolt led to the ground fall—a convergence of factors at the worst possible moment. On such a short route (40’) and with the crux near the midpoint, successfully clipping the third bolt was of tantamount importance.

An unidentified climber top-roping New Kids on the Block (5.10b) in Socorro Box Canyon. In the accident described here, Climber 1 failed to clip a bolt that is hidden from view by the climber's body, and then fell from just below this spot. The Edelrid Ohm is an "assisted-braking resistor" that is useful in such situations by increasing the rope friction in a fall, thereby compensating for a heavier lead climber.
