### Leader Fall — Inadequate Protection

California, Yosemite National Park, Half Dome

Author	Yosemite National Park Climbing Rangers
Publication	ANAM
Volume	13
Issue	77
Page	
Copyright Date	2024
Article Type	Accident reports

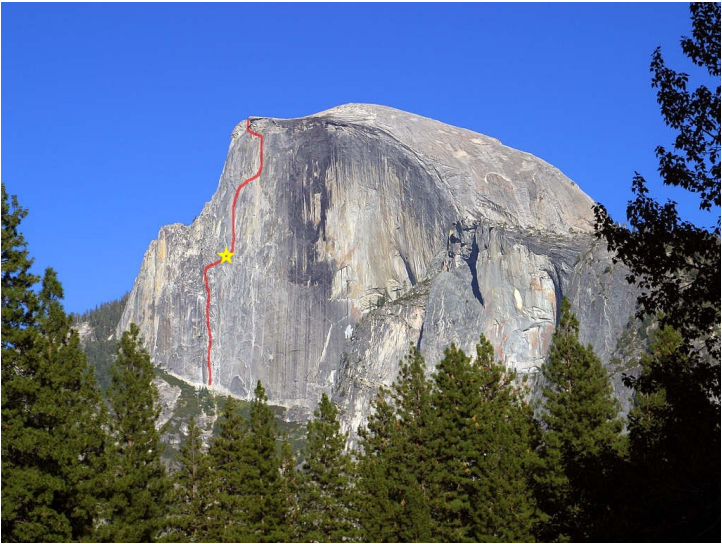
Due to the wandering nature of the pitch, this climber decided to remove a previous piece of protection to prevent rope drag. The climber placed a 0.3 cam in what appeared to be solid rock, planning to lower off this new piece in order to clean the previous cam. When the climber weighted the 0.3 cam, the surrounding rock broke, causing a 40-to-50-foot tumbling fall. Several other pieces of protection pulled, contributing to the substantial fall.

The Regular Northwest Face of Half Dome saw a serious leader fall on July 7 (yellow circle) when a cam pulled out. Tuxyso | Wikimedia

- **Do not underestimate easy terrain.** It is common for experienced and inexperienced climbers to get injured or killed in easy terrain. Letting one's guard down increases the likelihood of an accident. Regardless of the relative difficulty, continue to be mindful and situationally aware.

- **Maximize route familiarization.** Climbers should carefully study climbing and descent routes ahead of time. This information can be gleaned from topos and by seeking beta from experienced climbers. These efforts can enhance route-finding and overall safety by helping to prevent diversions onto unstable terrain. (Source: Yosemite National Park Climbing Rangers.)
