Fall on Rock — Quickdraw Unclipped from Bolt Hanger

Colorado, Clear Creek Canyon, Catslab

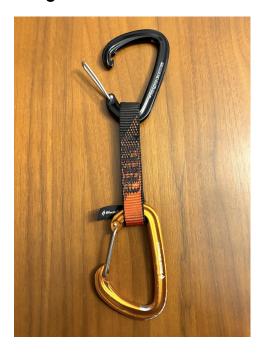
The quickdraw that failed at Catslab. The carabiner's wire gate is not bent, but rather displaced to one side. When the carabiner was loaded, it must have momentarily opened, because the gate notch shows no damage. Photo: Climber 2

I cannot think of anything that either of us did wrong. I believe that, while I was falling, either the rope or my body caused the carabiner connected to the bolt hanger to rotate inside of the webbing loop on the dogbone. The loop crossed the carabiner's wire gate and, when loaded, bent the wire to one side. As it deformed, it released the quickdraw. The flipped carabiner remained attached to the bolt hanger. The remaining carabiner and dogbone came down with me, attached to the rope. I'm not sure I could have done anything differently. (Sources: Climber 2 and the Editors.)

The quickdraw that failed at Catslab. The carabiner's wire gate is not bent, but rather displaced to one side. When the carabiner was loaded, it must have momentarily opened, because the gate notch shows no damage.
