AAC Publications

Fall on Ice — Collapsed Ice Pillar

Montana, Hyalite Canyon

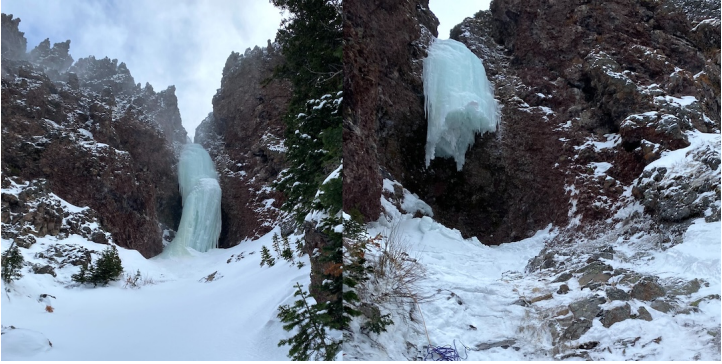
From a closer vantage, Smith confirmed that the upper part of Code Red appeared attached to the rock and, according to the article, “gave its stability no further thought.” At 15 feet up, Smith heard a cracking noise from above. The bottom half of the pillar then collapsed, toppling “like a falling tree.” Smith said, “I remember seeing a chunk of ice fall past me with my tool still in it.”

The point of detachment was 35 feet above Smith. With no intermediate protection, she—and the unanchored Lasko—“rocketed down the 30° approach slope.” Smith had been climbing on the lower-angle (left) side of the formation, and the inclined column fell away from her, so she avoided being crushed. The pair slid alongside the pillar before self-arresting after 100 feet, and they emerged unharmed.

Smith did well to assess temperature patterns in the days prior to the outing. She also chose a line that appeared well-bonded to the top of the cliff. While Smith was surprised at the collapse, it’s worth noting that the unusual crooked profile and obvious break in the column indicated the pillar had previously cracked and toppled partway, before refreezing at a Pisa-like tilt. Inclined columns are subject to axial compression, shear forces, and, in this case, buckling. Smith says she now completes a full 360-degree inspection of any free-standing ice pillar before climbing. (Sources: *Climbing* magazine and the Editors.)

Code Red (WI5) before and after a dramatic collapse in January 2023. The lower column was clearly leaning to the right, but appeared too big and solid to collapse. The two climbers involved in this accident were fortunately unharmed.
