Leader Fall on Rock — Placed Inadequate Protection

Montana, Beartooth Mountains, Granite Peak

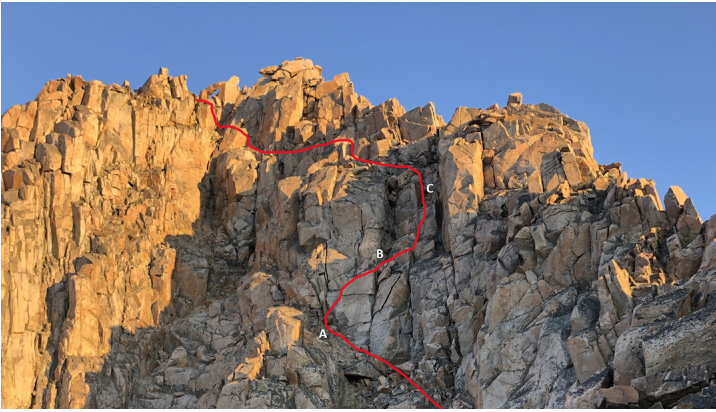
The red line shows the route on the upper east ridge of Granite Peak. A) The large ledge below the start of the 5th-class climbing. This is where the group waited for the helicopter. B) This is the location of the belay/rappel anchor at the top of the first 5th-class pitch and clients' location at the time of the fall. C) Approximate point from where Clark fell. Photo: Adam M. Clark

The red line shows the route on the upper east ridge of Granite Peak. A) The large ledge below the start of the 5th-class climbing. This is where the group waited for the helicopter. B) This is the location of the belay/rappel anchor at the top of the first 5th-class pitch and clients' location at the time of the fall. C) Approximate point from where Clark fell.
