AAC Publications

Fall on Rock — Carabiner Cut Rope

West Virginia, Monongahela National Forest, Seneca Rocks

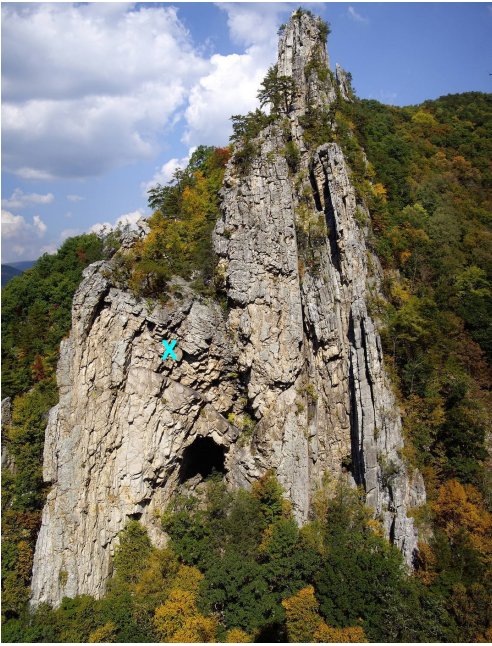
The third and final pitch of Simple J Malarkey climbs through the overlaps and triangular roofs seen here rising above and slightly left of the prominent cave. This pitch was the scene of a fatal rope-cutting accident (marked with a blue X) in August 2023.

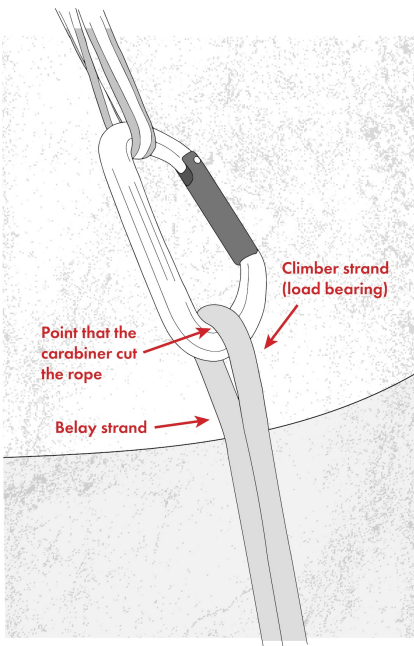
Evidence points to the rope being cut by the carabiner on the extended alpine draw attached to the number 3 Camalot. The carabiner remained attached to the fully extended alpine draw and was found lying on a slabby portion of rock just below the Camalot. Fuzzy remains from the rope sheath were found inside the carabiner. No rope sheath material was found on any nearby rock edges or the slabby rock face.

The rope leaving the belayer moved up through the first piece and past the slightly overhanging rock above. The overhang included a six-to-eight-inch-wide V-slot that likely inhibited the belay strand from moving laterally to the right. At the time of impact, the belay strand of the rope would have been lying on the slabby rock face above before entering the backside of the carabiner, which in turn was clipped to the extended draw and number 3 Camalot. In the same way the load strand in an ATC Guide locks down on the belay strand, so did the leader’s end of the rope. It wrapped around the carabiner, crushing down on the belay strand and the rock below it, and thus focusing the entire load of the fall onto the small section of rope between Gerhart and the cam.

In essence, Gerhart took a factor-two fall onto the carabiner. In fact, he may have achieved something greater than a factor-two fall, as the pinched rope effectively reduced the rope in the system to around six feet. I’ll leave it up to someone more qualified to calculate the force load of a climber falling an estimated 9 to 11 feet on around six feet of rope and all that energy being applied at the bend at the carabiner and onto the belay strand. Needless to say, it was enough to instantly sever the rope.

One tragic fact: It’s quite possible that Gerhart’s extended sling may have perfectly positioned the carabiner at the time the piece was placed, but then tragically the carabiner shifted into the fateful position. Had the carabiner been just two inches to the left or right, it would no longer have been lying on rock but hanging in free space. Would extending the sling on the first piece Gerhart placed have changed the location of the carabiner in question at the time of impact? This is unknown, as the first piece was ultimately removed by the belayer before they rappelled to the ground, so we were not able to replicate exactly how the rope was running.

In this highly unusual accident, the carabiner on the rope-bearing end of an alpine quickdraw appears to have acted like a belay device configured in guide mode. The load-bearing/climber strand (on top) trapped the belay strand (on bottom, under the carabiner) between the carabiner and the rock. The rope was severed. No rock edge was involved in cutting the rope, and no rope sheath material was observed on the rock.
