AAC Publications

Fall on Rock — Belay Failure from Above

Mexico, Nuevo León, El Potrero Chico

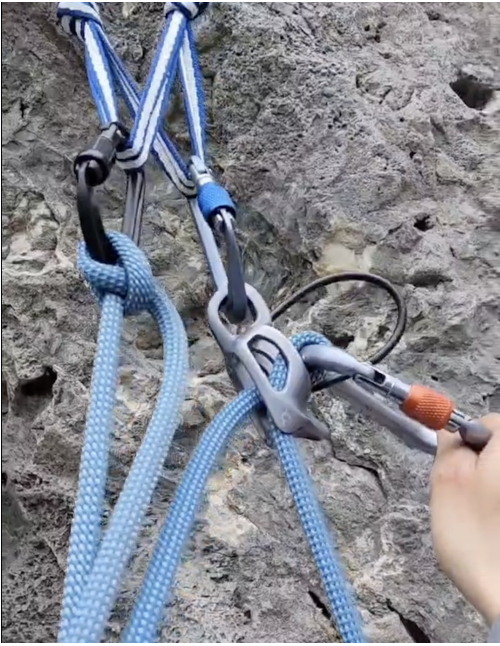
My partner was belaying with a Black Diamond ATC Guide, rigged in guide mode off a bolted anchor. (See Fig. 1, showing the anchor and belay configuration.) He had double-checked the system by pulling on the climber's side of the rope. I climbed to the eighth bolt, right before the crux on the pitch. I decided to hang to check out the moves. I said, "Take." I was on the rope for five to ten seconds when suddenly I began to free-fall. I remember the sky moving farther and farther away, so I must have been falling face up. I thought I was going die.

"We also tried to analyze the cause of the autoblock-system failure. From the photo of the belay configuration, we can confirm the ATC was set up correctly. (The climber's strand initially was on top but got pulled down beside the belayer strand due to the falling impact.) After some experiments, we found that the autoblock system might fail if (1) there was a horizontal component of force pulling outward (which might have occurred since the belay station was above a bulge, causing the belay components to lie against the rock) and (2) the wire of the ATC was caught by some small structure on the cliff. (See Fig. 2.) This scenario is very unusual and, again, can be completely avoided by always keeping a hand on the belayer's side of the rope, but that's the best estimation based on our experiments.

At this point, the rope locked in the now loaded ATC. The newness of the rope also probably played a role. Note that in Fig. 1, the climber's side of the rope is loaded adjacent to the brake side, not on top, as per the intended design. This is probably due to the force of the fall and the slickness/diameter of the fresh rope. Extra caution must be taken when using a thin and slick rope.

Fig. 1: This is the actual anchor and belay configuration immediately following the accident on Time Wave Zero. Liu Yuezhang

"There were a few mistakes made. The most apparent was when the belayer released both hands while belaying. This should be strictly avoided even with an autoblock system. My fall could have been caught if the belayer had pulled on the correct (belayer's) side of the rope; unfortunately, he attempted to pull the climber's side.

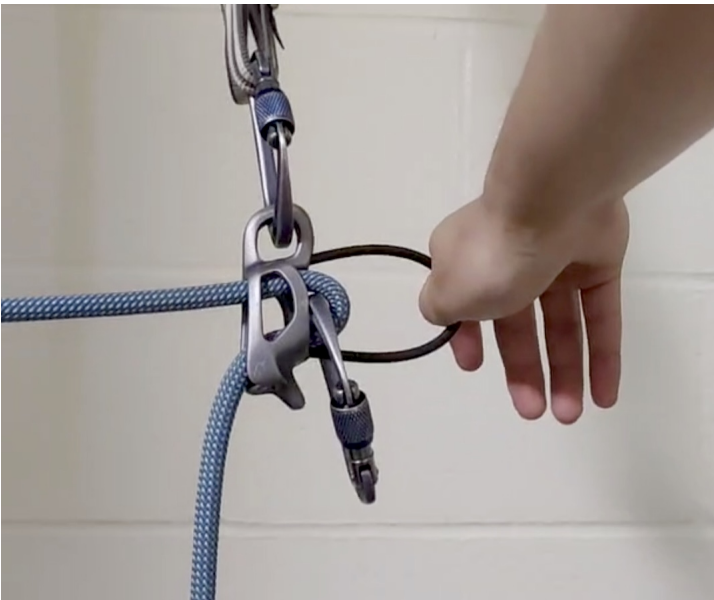
***Editor's Note:** It is possible that when Yuezhang called "take," the belayer may have grabbed the bight carabiner (or the ATC retaining wire) to disengage the rope/ carabiner/device in order to more easily take up slack through the device. While this is not recommended by the manufacturer, it is not an uncommon technique. Yuezhang recalls, "If my memory serves me, the belayer told me he first pulled the slack when I called 'take.'" Thus, it is plausible that the belayer, finding it difficult to pull in slack, disengaged the rope. When the bight carabiner or retaining wire is pulled upward, it also orients the rope perpendicular to the top of the ATC (as shown in Fig. 2). In this case, the ATC might have been pulled horizontally. If the belayer did just that, while Yuezhang momentarily shifted his weight on and off the rope, the rope could have begun to slip rapidly through the ATC.

Fig. 2: This shows how the ATC orientation can potentially allow the rope to run through the device in guide mode.
