## AAC Publications

### Ground Fall — Multiple Pieces of Protection Pulled

California, San Diego, Mission Gorge

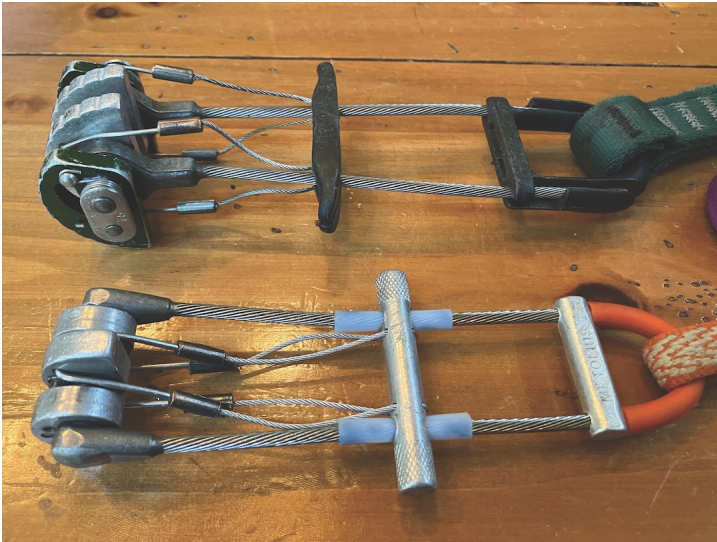
A ground fall occurred on May 18, when two cams pulled. Both are over 30 years old. The Metolius TCU is an old version with all cams an equal width. Later, the single middle cam was widened to provide more opposing surface area. The U-stem Black Diamond Camalot Junior is from the mid-1990s. This version's cam lobes were fabricated from very hard 7075-T6 aluminum—a material implicated in several incidents in which the cam lobes tracked out of apparently perfect placements. Both models of gear have been improved over the decades and form the backbone of many standard trad climbing racks. Photo:

One of the pulled pieces was a number 3 (orange) Metolius TCU. The plastic trigger-wire guide on a green (0.75) Camalot was tweaked and was probably the other that pulled. I'm not sure which pulled first. My partner suffered a severe traumatic brain injury, but he made it through surgery and has mostly recovered.

Perhaps Mission Gorge's slick rock, combined with recent rain that generated dirt and silt contributed to the gear pulling. The gear itself may have played a role (see photo opposite). Not up for conjecture is that several elements combined to produce an unpredictable accident. The fallen leader was 34 years old and had "many years" of trad experience. The cams did not suffer obvious deformation that would have indicated a high load. As the belayer stated, "They just came right out, with seemingly less than body weight. They didn't slow the fall at all." (Sources: Anonymous and MountainProject.com.)

A ground fall occurred on May 18, when two cams pulled. Both are over 30 years old. The Metolius TCU is an old version with all cams an equal width. Later, the single middle cam was widened to provide more opposing surface area. The U-stem Black Diamond Camalot Junior is from the mid-1990s. This version's cam lobes were fabricated from very hard 7075-T6 aluminum—a material implicated in several incidents in which the cam lobes tracked out of apparently perfect placements. Both models of gear have been improved over the decades and form the backbone of many standard trad climbing racks.
