### Rockfall — Rock Dislodged During Intentional Fall

New York, Shawangunks, Trapps Area

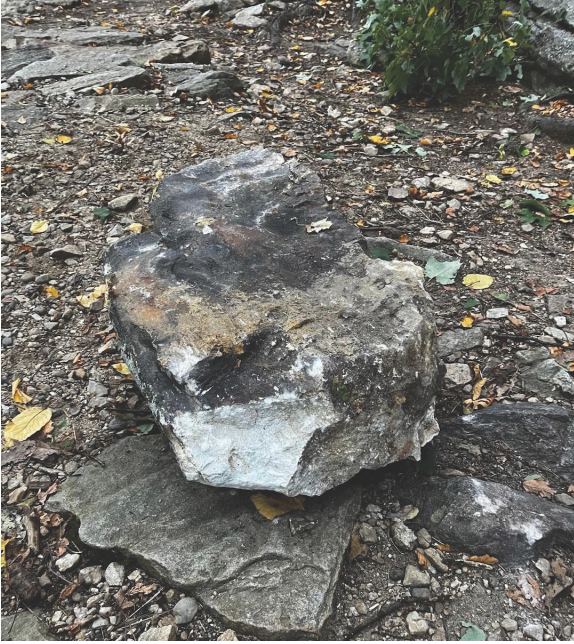
After at least one fall, the climber ascended and fell again, intending to be caught by the same cluster of gear. However, the force of falling dislodged a large piece of the rock feature where the gear had been placed. As he fell, the rock struck the climber in the face and head. The climber’s fall was eventually arrested by his next closest piece of gear.

While it is common for climbers to take leader falls on traditional gear in the Gunks, intentional lead falls are less typical. This incident highlights the potential risks of applying indoor training techniques to outdoor environments. Outdoor climbing demands full consideration of many aspects not found indoors. In this case, specific gear placements, interpretation of terrain features, and choosing what to fall on all came into play. This accident underscores the importance of carefully inspecting the rock and surrounding features before committing to falls.

In October, a climber was taking practice falls after attending a “Fall Therapy” clinic that was taught indoors by a certified guide. This led to a serious accident when a chunk of rock was dislodged, striking the climber after he stopped falling. The above rock weighs about 1,000 pounds and represents half of the falling rock, which broke upon impact with the ground.

Additionally, the potential absence of a pre-established “worst-case scenario” plan and clear communication between the climber and belayer may have contributed to the severity of the incident. Climbers should have a mutual understanding of risk management and safety measures, especially in an outdoor environment. This might include how to anchor an unconscious climber in order to release the belayer. (Source: Mohonk Preserve Rangers.)
