### Leader Fall on Ice — Insecure Tool Placements

Canada, Alberta, Jasper National Park, Tangle River

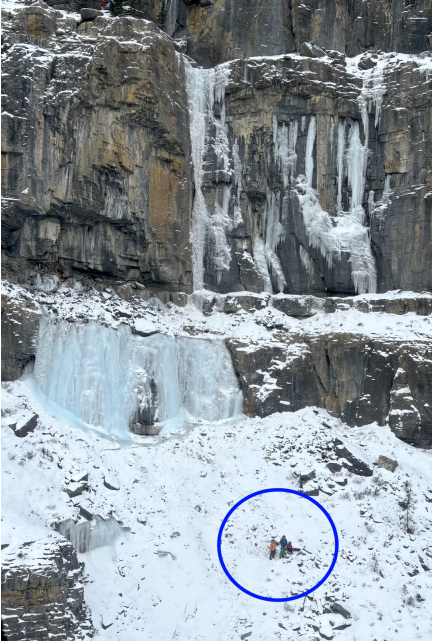
**On December 27, three climbers were attempting the Rick Blak Memorial Route (WI5), a 30-meter ice climb in Jasper National Park.** The leader was nearing the top of the pitch when her ice tools popped, resulting in a ten meter fall caught by a 13-centimeter ice screw. During the fall, her crampon caught on the ice and was ripped from her boot. The resulting force broke her lower leg.

Climbers (blue circle) awaiting rescue at the base of the Rick Blak Memorial Route. A climber fell near the top of the pitch and was moved to an open area to be extracted.

The climber had placed adequate protection and was reported to be just above her last screw. The party was very experienced, and their VHF radio facilitated a quick rescue with good communications. Moving the patient to a safe open area reduced risk to rescuers. The team had gotten an early start and thus, when the accident happened, it was still early in the day. This gave ample time for the rescue during the short December daylight hours. The accident was a good reminder that all falls on ice can be dangerous and that it is always a good idea to test tool placements and climb well within one's abilities. (Source: Parks Canada.)
