## AAC Publications

### Fractured Ribs — Belayer Pulled into Stick Clip

Arizona, Cochise Stronghold, West Stronghold, Sheepshead Area, Mallethead

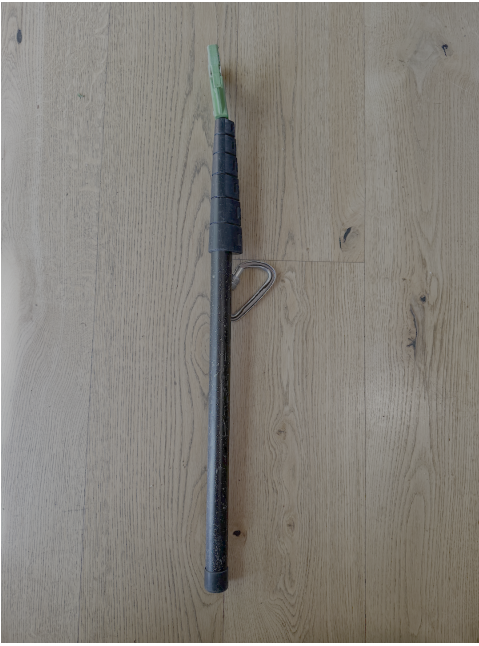
"Old Bendy" was at the center of an accident in which a belayer was pulled by a falling leader into the end of his stick clip, breaking five ribs. Photo: Mark Hammond

My buddy was leading, and I was worried that I was going to drop my pack off the ledge, so I took it off and clipped it to the single bolt. The stick was stuck inside the pack with the opening cinched down tight. A short time later, my buddy fell. I was twisted and pulled into the stick. The clipping end center-punched me in the ribs. I broke five of them, strangely enough from the back. It's possible that it shifted to that position when I was pulled by the fall since my rope was also clipped to that bolt.

Improbable as it seems, this accident illustrates an unforeseen hazard. Hammond is an AMGA-certified guide, and clipping the pack in was the smart thing to do. Unfortunately, he unknowingly positioned a rigid, blunt object at torso height directly in the line of pull during a leader fall.

"Old Bendy" was at the center of an accident in which a belayer was pulled by a falling leader into the end of his stick clip, breaking five ribs.

This accident is worth considering for anyone who carries a stick clip. Leaders often clip one to their harness or leave it on a lower bolt while working sequences above. A fall with or onto the stick could cause serious injury. Using webbing or cord to create a flexible connection point, rather than clipping directly to the stick's eye, might prevent it from aligning with a falling body.
