### Fatal Fall — Incomplete Tie-In

Colorado, New Castle, East Elk Canyon

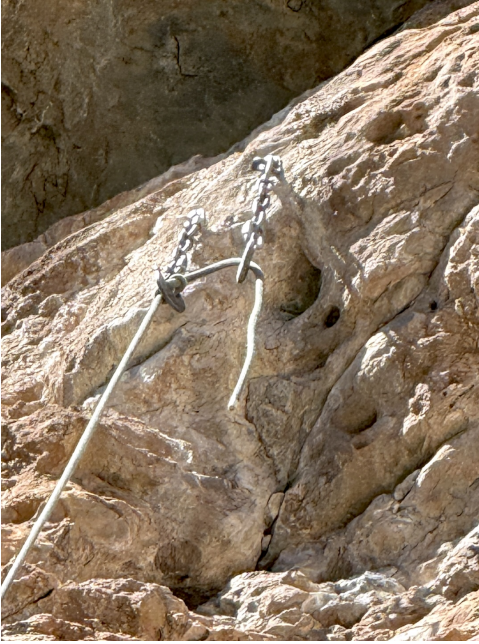
Seen here, an incomplete follow-through figure-8 knot led to a lowering fatality in East Elk Canyon on the Western Slope of Colorado. Photo: Garfield County Sheriff's Office and Coroner

Examination of the harness revealed no signs of excess wear or failure. The climbing rope was not attached to the harness. The following day, one of the first responders returned to the site and photographed the rope, which displayed a single-strand figure-eight knot jammed into one of the mussy hooks at the anchor. It is believed the climber had begun tying a figure-eight follow-through but did not complete it after threading the rope through his harness tie-in points. While climbing, the incomplete knot was likely not weighted sufficiently to reveal the error. When the climber weighted the rope to be lowered, the incomplete knot failed.

A figure-eight follow-through must be fully threaded through both harness tie-in points (leg loops and waist belt) and be finished and dressed before loading. An incomplete knot may hold under light or no load, which is consistent with the climber completing the route and then having the knot fail when he weighted the rope.

Seen here, an incomplete follow-through figure-8 knot led to a lowering fatality in East Elk Canyon on the Western Slope of Colorado.

Whether a partner check was conducted before the climb is unknown—a thorough partner check would likely have identified the incomplete knot. Partner checks are a standard practice because a climber who has just tied in is poorly positioned to verify their own knot. Familiarity and confirmation bias make self-inspection less reliable than a second set of eyes. This is especially true for experienced climbers, for whom tying in is so automatic. Experience does not protect against errors; partner checks do.

Finally, while climbing is a social activity, too much communication at the wrong time can lead to distraction. When starting a process, finish it. Do not interrupt another climber when they are performing critical tasks. (Sources: Rob Glassmire, Garfield County Sheriff's Office and Coroner, and the Editors.
