### Pendulum Fall — Poor Top-Rope Position

Virginia, Great Falls Area, Sandbox

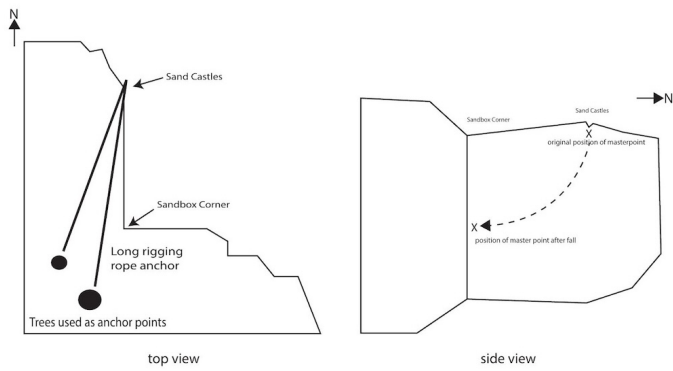
I looked over the edge to see the fallen climber hanging about 20 feet below. He had clipped the masterpoint to his harness and leaned back, at which point the V-notch had released the masterpoint, swinging the climber leftward into the dihedral of Sand Box Corner. He complained of leg pain—I discerned a badly displaced fracture. He could not unweight the system, so I quickly set up a new anchor so I could fix a line and rappel to him. Having arrived at the cliff base, my partner Tim Murphy ascended a nearby rope and confirmed, as I’d observed, that the climber was connected via his belay loop directly to the anchor’s masterpoint.

At most mid-Atlantic top-rope crags, there is usually no fixed gear—top-ropes are typically clipped to long static lines anchored at or back from the cliff top using trees, boulders, or gear. This anchor had been set with a fundamental misunderstanding of the fall line and direction of load if the masterpoint migrated from the small rock notch. This V-notch had been adequate to hold the masterpoint in position while the system was loaded from below, but it was not adequate once the victim was level with the masterpoint and moving around. He had called, “Off belay,” and was clipped directly to the masterpoint when it released from the notch, swinging him 20 feet into the dihedral as the anchor line skittered along the cliff top. A more secure redirect like a piece of gear or a tie-off that pinned the masterpoint in place would have prevented this accident.

Diagram of the anchor configuration and fall line at Sandbox, Great Falls, Virginia.

The climber seemed to be unaware of the concepts of extension and directional load in anchor design; topping out and going off belay also seemed outside his experience. Climbers should get instruction from a guide or mentor before venturing into unknown territory. (Source: Eunny Jang, AMGA Apprentice Rock Guide, Certified MPI, SPI Course Provider.)
