AAC Publications

Fall on Rock – Inadequate Belay, No Helmet

Canada, British Columbia, Skaha, Foreplay Wall

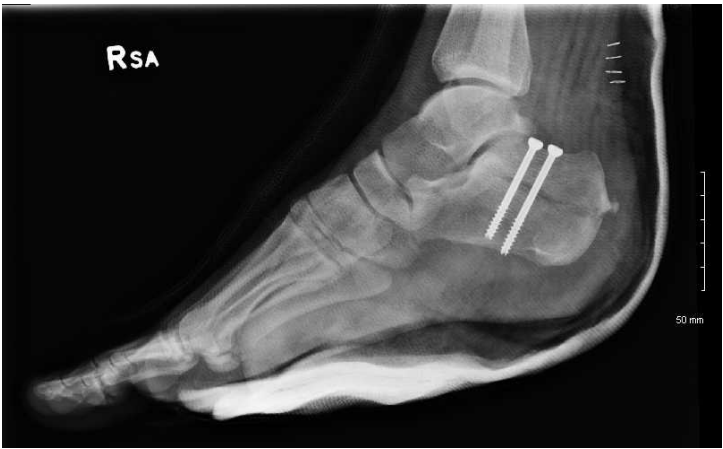
The climber landed on angled ground, which launched him face-first into some rocks farther down the slope. The impacts resulted in a broken right calcaneus—his shoe was split, and so was his heel to the bone—and a deep left-heel laceration. Multiple frontal facial lacerations were sustained, including a torn right nostril, and he had head trauma and a concussion. After two hours the injured climber was evacuated by helicopter. He spent six days in an intensive-care unit. At the time of reporting, about 10 days after the accident, he was still missing about 30 hours of memory, starting from around noon on the day in question.

An injured foot resulting from a groundfall at Skaha, British Columbia.

Climbers must be cautious when using thin or new ropes, which tend to be more “slippery” than ropes that have seen some use. The climbers observed that clipping a second carabiner between the belay loop and the ATC would have added more friction. The use of a tube-style or assisted-braking belay device specifically designed for thinner ropes also might have helped. Fundamentally, however, a good belay stance and position, combined with proper braking technique (brake hand held firmly on the rope below the belay device, ready for a fall), are the keys to preventing such accidents.
