### Rope Sheath Destroyed

Colorado, Boulder Canyon

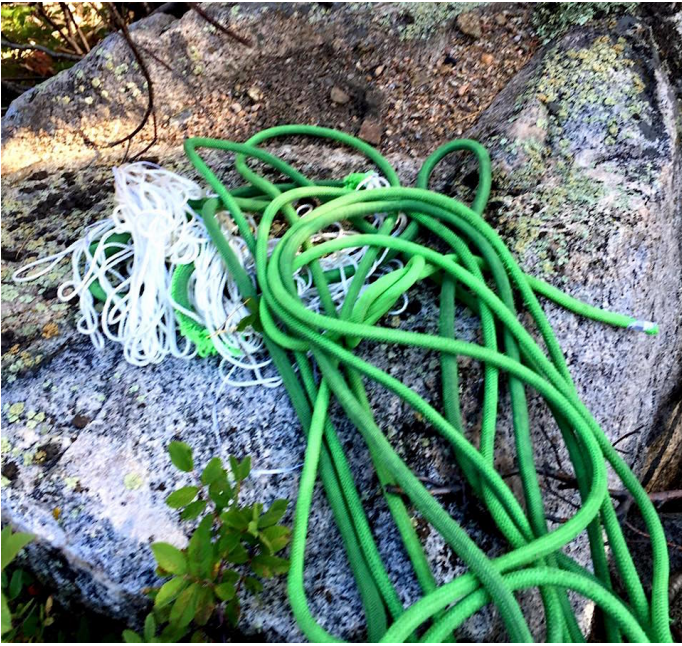
**On September 12, I had a near miss when I was climbing a sport route called Twist and Shout (5.13c) at Coney Island in Boulder Canyon.** The route has four fixed quickdraws on the overhanging top half of the route, two of which are regular quickdraws with a nylon dogbone, and two of which are chain-link draws with regular aluminum carabiners on the clipping ends. I briefly looked at the carabiners as I clipped them on my onsight attempt and did not notice any excessive wear or grooving. As I fell above the third fixed draw, which was a chain-link draw with an aluminum carabiner, the biner cut the sheath of the rope, exposing nearly 20 feet of the core.

While Boulder Canyon is an extremely popular place to climb, this particular route is somewhat obscure and does not see a lot of traffic, so the condition of the fixed gear is not well-documented. Instead of going bolt to bolt to inspect the moves and the fixed gear, I was focusing on an onsight attempt and only gave the fixed draws a cursory inspection (the clips were difficult). Most of the danger from fixed draws comes from excessive grooving when the carabiner gets worn down. However, carabiners that come in contact with the bolt hanger can get nicks, abrasions, and small, rough teeth that are hard to see without careful inspection. When these carabiners are then placed on the rope-receiving end of the draw, such as for a replacement carabiner on a fixed draw, such burrs can knife the sheath. These can be very difficult to see, especially if you hang directly on the rope running through fixed draws when going bolt to bolt. If the condition of the gear is unknown, it's a good idea to clip directly into the bolt hanger with an independent draw, then fully inspect the fixed draw's condition before committing to using it. (Source: Jason Haas.)

Rope "de-gloved" by the carabiner on a fixed quickdraw in Boulder Canyon, Colorado.

[Editor's note: This report also highlights the importance of inspecting and replacing carabiners on fixed quickdraws frequently. Steel carabiners last much longer than aluminum biners in such uses, but even steel biners eventually can develop rope-damaging grooves, nicks, and burrs.]
