Lowering Error – Rope Pulled Through Device, No Helmet

North Carolina, Hanging Rock State Park, Moore's Wall

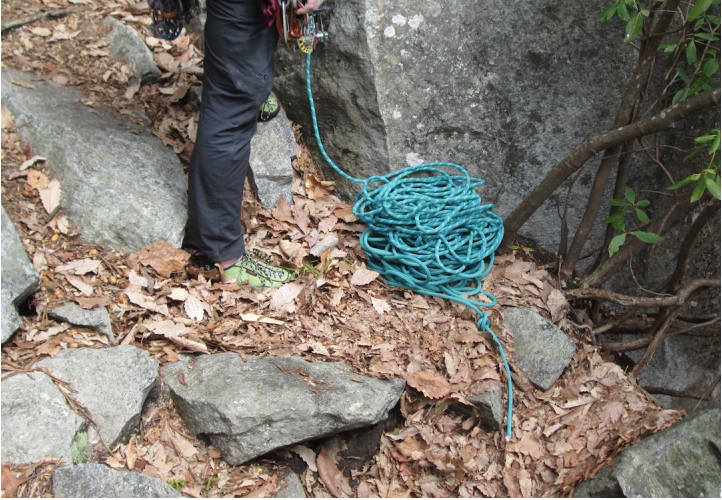
A stopper knot is one of the surest ways to prevent the rope from pulling through the belayer's device while lowering a climber.

This type of incident continues to be a problem at climbing areas across the country. These accidents can be prevented by closing the belay system, which can be done by: (1) Both climber and belayer tying into the rope; (2) Placing a stopper knot on the end of the rope; and/or (3) Tying the belayer's end of the rope to an anchor or rope bag. And, always wear a helmet. (Source: The Editors.)
