Two Ground Falls – Inadequate Protection, Rope Severed

California, Yosemite Valley, El Capitan

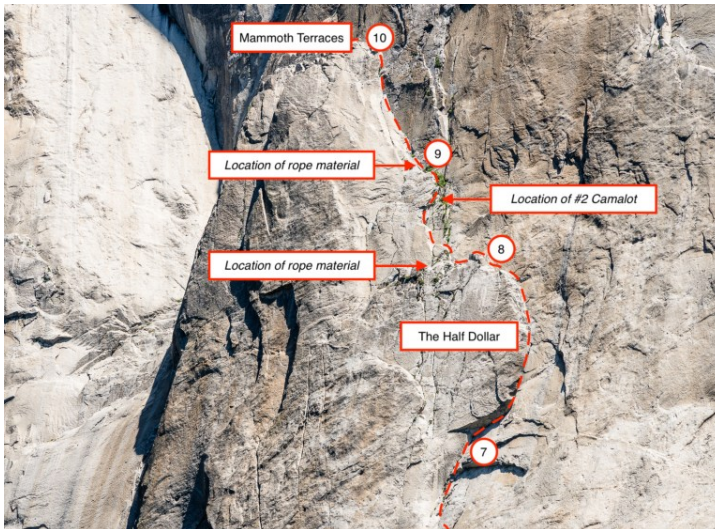
Wells was likely combining pitches nine and ten into a single pitch, thus avoiding the need to build a gear anchor at the top of pitch nine. Doing this would have meant that Klein would not have had enough rope to stay at the two-bolt anchor and belay at the top of the Half Dollar. However, it was determined by investigators that a 60-meter rope would reach the bolted anchor atop Mammoth Terraces from the location of the number 2 Camalot.

The rope was cleanly severed within a foot of Klein's harness. The investigation found boulders about 40 feet directly below the number 2 Camalot that showed evidence of sheath and core rope material. Approximately 40 feet above the Camalot, a block was found with rope fibers on two sides, indicating the fall may have been momentarily arrested at this location.

Investigators' diagram of the area on the Salathé Wall route where two men who were believed to be simul-climbing the ninth and tenth pitches fell to the ground when their rope severed.

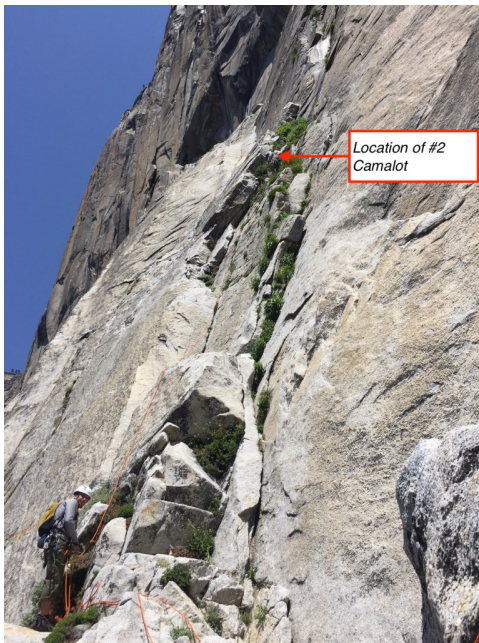
Upon reaching the anchor atop the Half Dollar, Prince found that his rope (the one Klein had trailed) had been short-fixed to two bolts. The remainder of this rope extended approximately 50 to 60 feet to a point where it ended at a number 2 Camalot clipped with a locking carabiner in the locked position. The Camalot was not placed at a significant ledge and was judged by investigators to be a temporary placement.

Editor's note: The mysterious and unplanned number 2 cam placement suggests that one of the climbers may have tied off the trail rope while dealing with a contingency above or below that point. Perhaps the rope between Wells and Klein got stuck or a piece of gear was dropped. It's possible that one climber fell while attempting to solve this unknown problem and then his fall pulled off the other. The full story will never be known.

Investigators' photo of the ninth pitch of the Salathé Wall, showing the location of the mysterious number 2 cam placement described in this report.
