Top-Rope Anchor Failure — Sling Cut by Sharp Rock

Wisconsin, Devil's Lake, Gill's Buttress

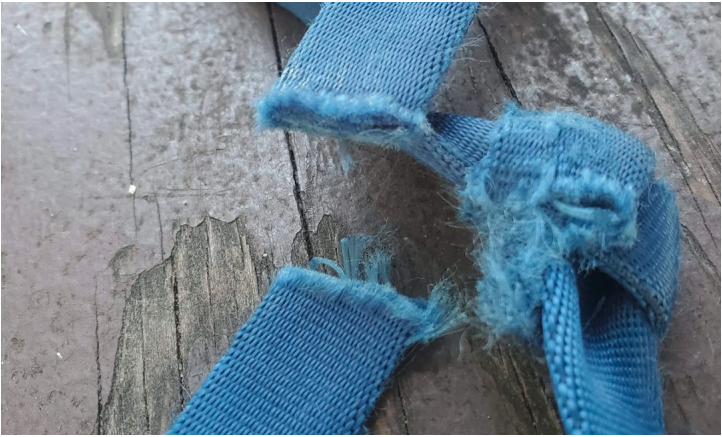
The top-rope anchor was set up in two parts. First, a large boulder on top of Gill's Buttress was slung as protection. To extend the anchor closer to the edge, a 60m Black Diamond nylon runner (about two years old and used only three times as intended) was clipped to the protection with a figure-8 knot. This sling was tied into a masterpoint with a second figure-8 knot. Two locking carabiners were attached to the masterpoint, and the rope was threaded through these carabiners. The accident occurred due to a failure of the nylon runner in the masterpoint loop, causing the rope, carabiners, and Climber 1 to fall to the ground, while the rest of the anchor remained on top.

Pictures of the sling indicate a relatively clean, linear cut. The quartzite at Devil's Lake is known for sharp edges, and climbers must be diligent in inspecting the rock at edges, corners, and breaks, including areas the anchor materials could "walk" to. It is unknown if the masterpoint had significant travel. Most likely, the direction of pull during Climber 1's fall partially cut the sling, and a moment after he weighted the rope, the nylon separated at the weakness. (Source: Close associate of Climber 1.)

This sling was tied to create a masterpoint loop for a top-rope anchor. The loop apparently rubbed against a sharp edge and cut.

The protection used, a large boulder, was an excellent choice for the area. However, the extension could have been improved by using thick, abrasion-resistant static rope. Otherwise, cordelette (long enough to be doubled) or two separate slings should have been used. Two loops in the masterpoint might have prevented this accident.

Editor's Note: In addition to creating a redundant top-rope anchor, consider padding the rock beneath anchor materials to protect against abrasion or cuts.

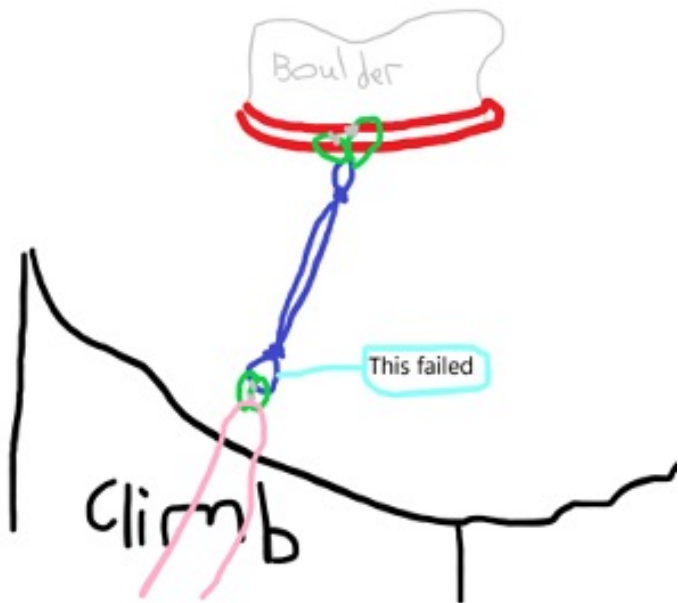
Sketch of the anchor set-up atop Gill's Nose, showing where the masterpoint loop rubbed against the sharp edge of the cliff top.
