AAC Publications

GROUND FALL—Broken Carabiner

California, Mickey's Beach, Kombucha Crag

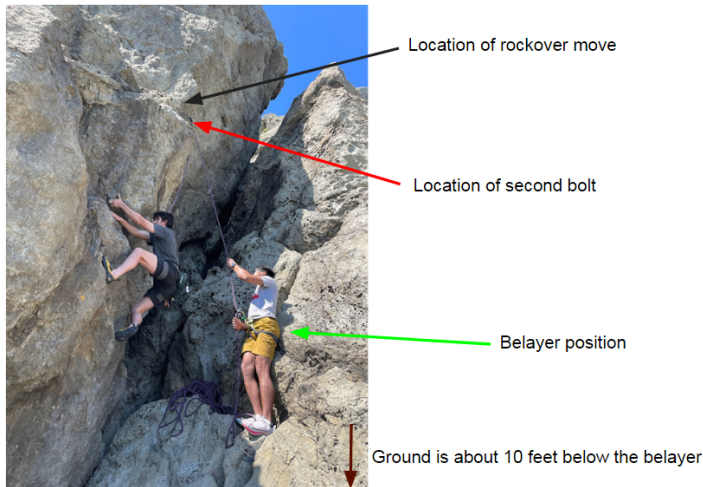
Climber 1 started up with the rope running through the newly stick-clipped second draw on the second bolt. The rope was back-clipped, running through the carabiner from the front, toward the rock, and then to his harness tie-in. He also did not clip the first bolt. With the pre-clipped bolt two feet to his right and at knee level, he fell. His rope caught him, and about a second later there was a sudden "PING!" noise and the quickdraw separated from the bolt.

Climber 1 and Climber 2 (the belayer) collided. The impact knocked Climber 2 off the ledge. Climber 1 believes he struck the ledge with his back and then flipped headfirst toward the ground, another ten feet below. Both Climber 1 and the belayer hit the ground and quickly stood up in shock. Climber 2 had hit his head on a rock on the ground. A clump of his hair was missing, but he was otherwise uninjured. Climber 1 was in shock and felt nauseous and light-headed, with abrasions on his right elbow. He also was experiencing pain in his lower back along with a burning sensation in his right thigh.

Diagram of the scene at Mickey's Beach. When a climber fell near the second bolt, the quickdraw detached from the bolt and the climber and belayer both fell to the ground.

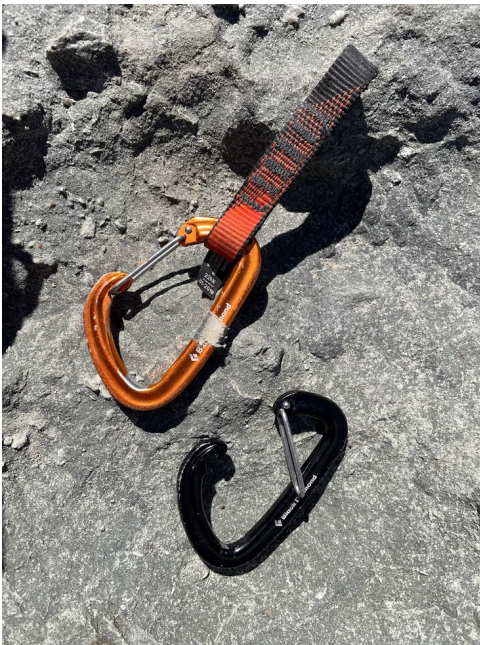
The quickdraw that had detached from the second bolt still had the rope clipped through the bottom carabiner. The upper carabiner was bent sideways out of alignment and stuck in a fixed position.

1. As I performed the rock-over move, I was to the side of the bolt and the rope might have pulled the quickdraw sideways. As I fell, the quickdraw carabiner might have been caught on the other and could not rotate back to the bottom of the hanger. This would have caused the gate to be cross-loaded (or opened).*

2. Because the quickdraw was stick-clipped behind the original draw, it's possible the gate got caught on the other quickdraw and never closed. This is harder to imagine because the carabiner would likely fall off before the gate saw significant load to bend it out of alignment.

3. The quickdraw that failed was back-clipped. We knew this as soon as we clipped the draw but figured I would be able to fix it once I got to a comfortable stance, and I would not be above the bolt. Additionally, the direction of the fall and the direction of the gate were such that we could not imagine the rope snagging the gate. The back-clipping could have caused the draw to twist during the fall, and that could have levered on the gate.

* Editor's Note: The bolt in question was a one-piece, titanium glue-in that has a tapered hanger that is not designed to accommodate two carabiners. It is quite likely that the draw's carabiner had been clipped over the original as it is very difficult to clip an additional carabiner under another on such a hanger—especially from below and with a stick clip. Having observed that the draw was back-clipped, it would have been easy to stick-clip both the first and second bolt, hoist up, clip directly into either bolt, and rearrange the draws and rope in the correct manner.

The broken quickdraw from the Mickey's Beach incident. The wire gate has been fixed in the open position, indicating that it was loaded while not engaged with the gate notch.
