Fall on Rock – Inadequate Protection, Inexperience

New York, Adirondacks, Wallface

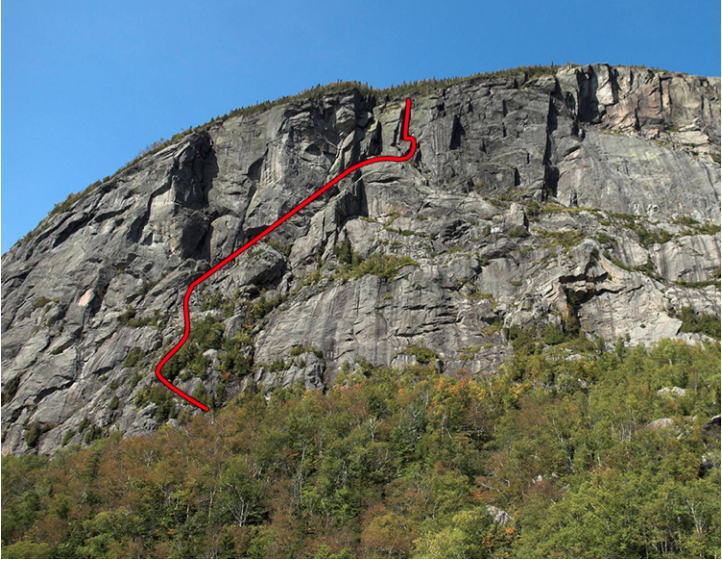
The Diagonal follows a long ramp line in the left center of Wallface. The 2015 accident occurred on the tree-dotted pitches below the ramp.
