Fall on Rock – Off Route

Alberta, Banff National Park, Castle Mountain

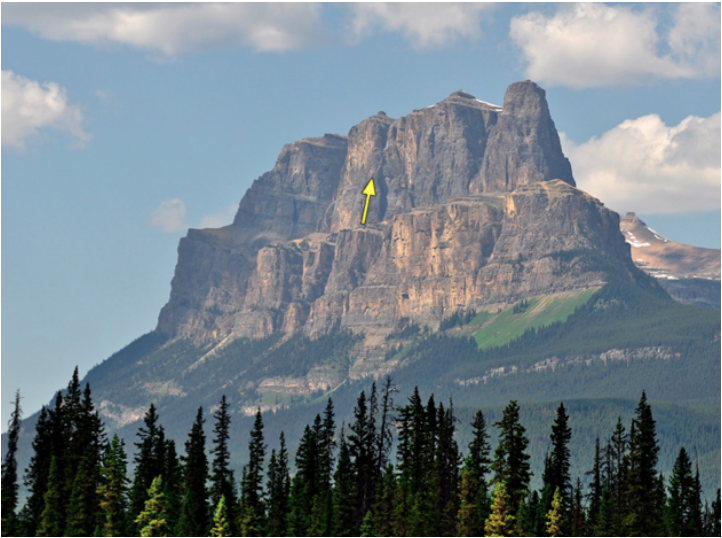
Castle Mountain. Arrow marks the approximate location of Brewer Buttress, above the Goat Plateau ledge.
