Stranded on Mt. Tupper – Inadequate Equipment

Canada, British Columbia, Glacier National Park, Mt. Tupper

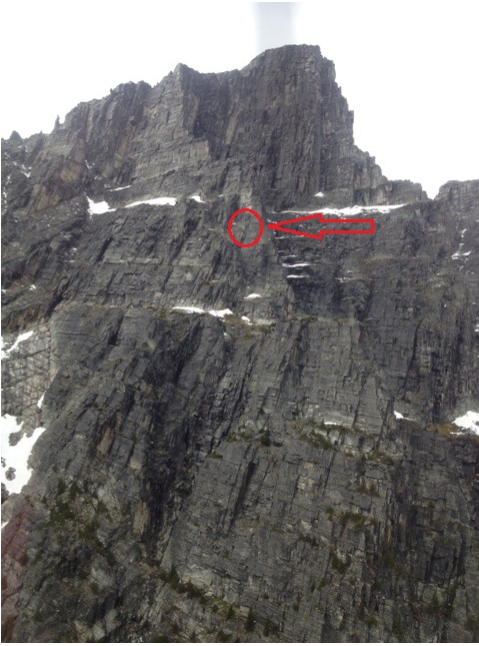
South side of Mt. Tupper with location of stranded climbers circled.
