Cathedral Peak Leader Fall – Off Route, Inadequate Protection

California, Yosemite National Park, Cathedral Peak

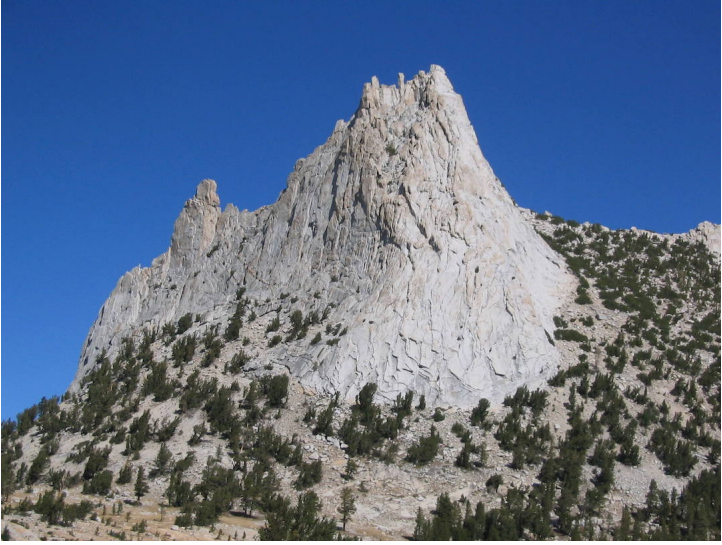
Cathedral Peak's popular Southeast Buttress Route (facing the camera) has many variations.
