Rappel Error – Anchor Failure, Inadequate Communication and Teamwork

California, High Sierra, Palisades, Starlight Peak

Author	Anonymous Report
Publication	ANAM
Volume	11
Issue	71
Page	53
Copyright Date	2018
Article Type	Accident reports

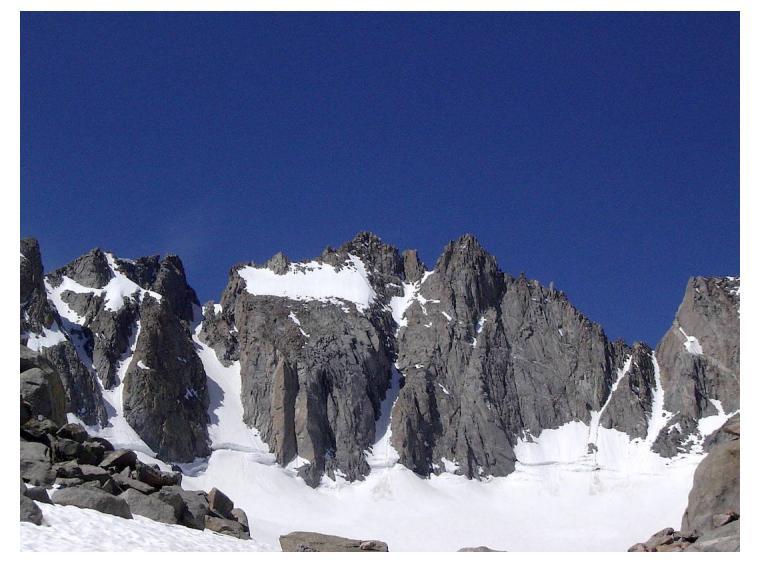
Starlight Peak (right center). The normal descent follows the right skyline to the snow couloir. The attempted shortcut headed dwon the steep sunlit face.
