AAC Publications

Fall On Snow – Inadequate Protection

Alaska, Denali National Park, Denali, West Buttress Route

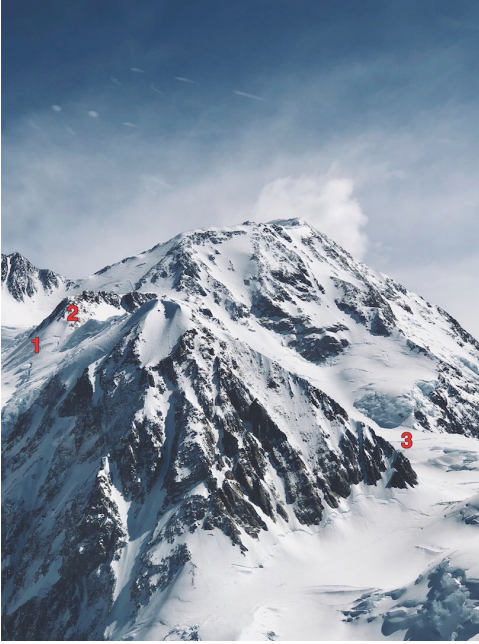
Aerial view of Denali, showing approximate locations of (1) the crevasse into which two climbers slid on May 20, (2) the West Buttress, and (3) the 14,200-foot camp. NPS Photo

Two climbers were ascending Denali's West Buttress at approximately 16,500 feet when they fell off the north side of the ridge (opposite the well-traveled route from the 14,200-foot camp). The fall occurred at 3:30 p.m. on May 20. The 29-year-old female and 27-year-old male climbers were roped together at the time of the fall, but with hard surface snow conditions and without any protection clipped between them, they were unable to arrest their fall. They slid about 1,000 feet and into a crevasse on the Peters Glacier.

Aerial view of Denali, showing approximate locations of (1) the crevasse into which two climbers slid on May 20, (2) the West Buttress, and (3) the 14,200-foot camp.

Roped glacier travel can provide a false sense of security. Failure to adapt fall protection methods to the current surface conditions has been the cause of many accidents. This is especially true when the surface becomes too firm for effective self-arrest. In softer snow conditions, where self-arresting is possible, solid footwork and using a mountaineering axe may be sufficient protection. As the surface hardens or transitions to ice, running protection (e.g. pickets or ice screws) is required to arrest a falling team member. The transition from soft to hard footing may be subtle, and conservative risk management strategies should be employed. The icy and rocky terrain of the West Buttress ridge is a location that requires running protection to effectively arrest a fall. (Source: Denali Mountaineering
