Ice Climbing Ground Fall – Rapidly Changing Conditions

Canada, Alberta, Banff National Park, Mt. Wilson

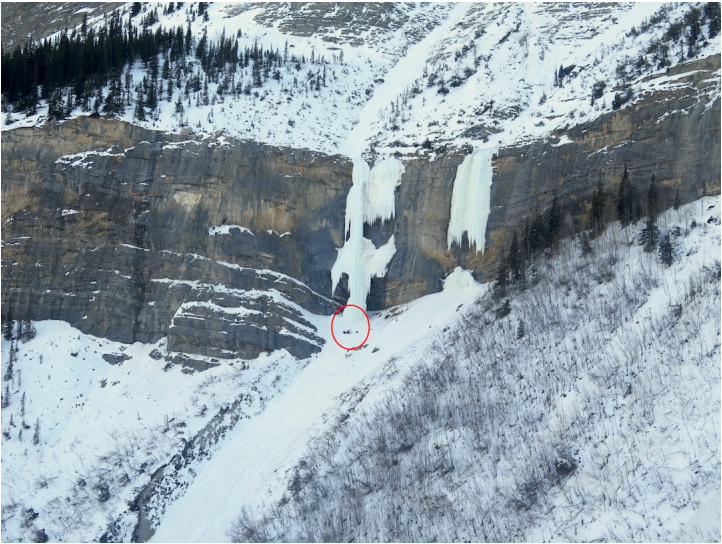
At around 7 a.m., the leader started up the first pitch. When he was about four meters up, his tool sheared through some chandelier ice and he fell to the ground. He landed on his feet, but complained of back pain and other concerns. The party had a radio, so they called Parks Canada for help.

- (4) **Not adapting to changing conditions.** The climb had freshly formed chandelier ice on the surface. The leader had already downclimbed the first five meters once, due to the conditions, and was checking out a new line when he fell. In his words: “About ten to 15 [feet] off the ground I started to slow down and consider my options again. I didn't like it, but it did look okay higher up. As I was pondering my options, one of my tools sheared and I pitched. It was too low to have gear in, and the ice was horrible anyway. My mistake was not in the protection system but rather my inability to slow down and climb more carefully. Conditions had changed rapidly.”

Accident site below the Ice Nine route on Mt. Wilson. The patient fell to the ground when a tool sheared through chandelier ice.

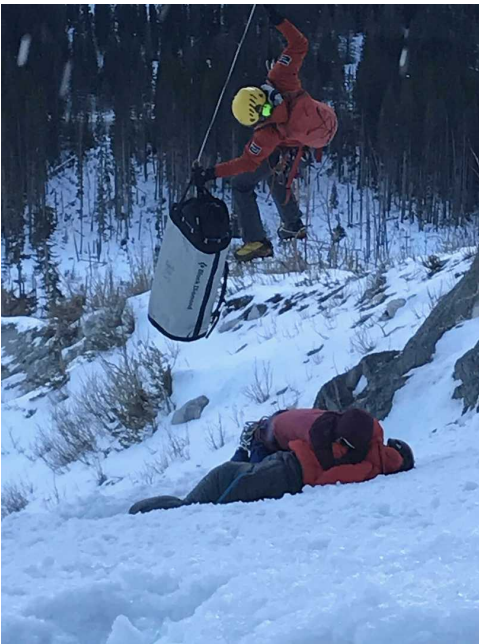
Rescuer arriving by helicopter at the accident scene.
