### **Fall on Rock – Inadequate Protection for Second**

Colorado, Eldorado Canyon, The Bastille

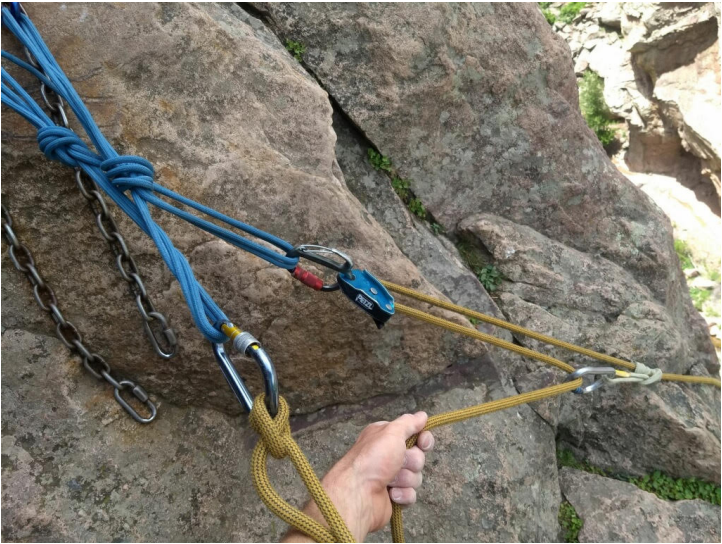
Reconstruction of a 3-to-1 haul rigged on the Werk Supp anchor to assist an injured climber to the belay ledge. The Grigri acts as a progress-capture device; a plaquette belay device in guide mode will serve the same purpose.

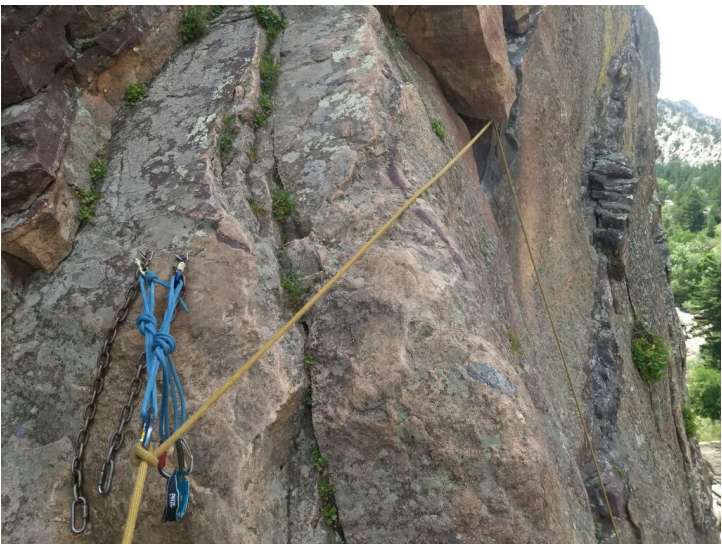
Austin had only climbed outside five times and never on anything this difficult. As I was climbing, I was more focused on protecting the route for me than for the person who would be following. Placing another piece of protection after the final difficult move, before the downward traverse, would have protected the follower from a significant swing. Another option would be to build an anchor directly above the first pitch, rather than using the bolted anchor off to the side. [Editor's Note: Many climbers exit this pitch to the left via a lower traverse, heading more directly to the bolted anchor; this is safer for the second climber.] It's also worth noting that the climber initially only suspected a sprain, but the injury actually involved a fracture that required surgery. Neglecting to seek medical attention for even longer could have led to further complications. (Source: Bill Kinter.)

A rope running over the final section of the first pitch of Werk Supp, with protection placed below the final hard moves of the direct finish. If the second falls after cleaning this piece, he or she will take a hard swinging fall.
