## Falling Ice – Running in Crampons to Escape Debris

Washington, North Cascades National Park, Mt. Goode

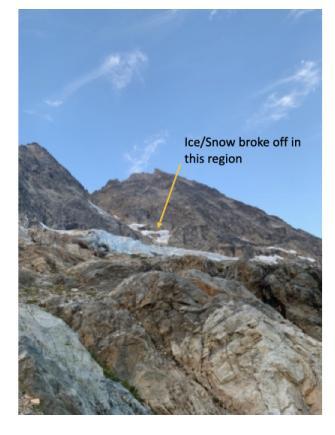
On September 5, two experienced climbers (female, 32, and male, 36) were attempting to climb the Northeast Buttress of Mt. Goode. A little after 10 a.m., as they were trying to cross from the Goode Glacier onto the start of the rock route, a large piece of ice broke free from the gully above. As chunks of ice began to fall toward the party, the female climber, who was more exposed to the falling ice, ran downhill. During this effort to escape the ice, she caught her crampons on the glacier, stumbled, and fell. She was able to quickly self-arrest and avoided being struck by any of the large chunks of ice. However, due to the fall, the climber injured both ankles (with the crampons likely contributing to the severity of the injury).

The area where falling ice led to an accident on the Goode Glacier.

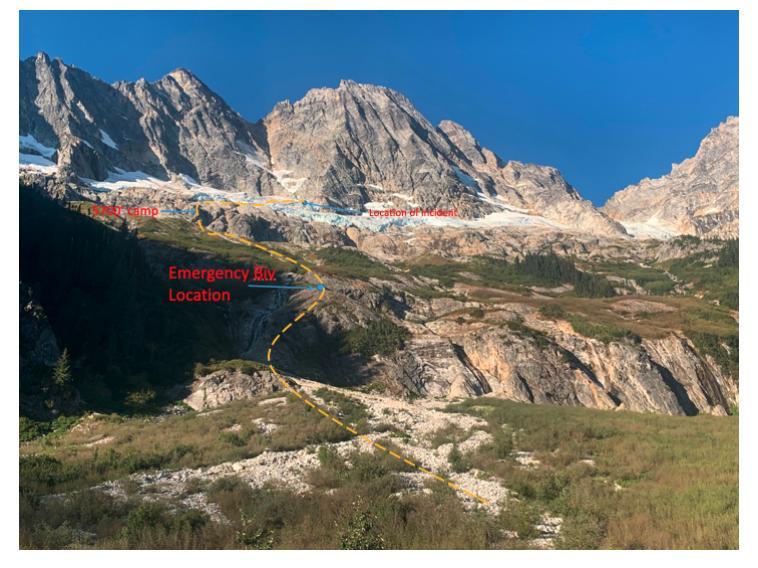
View of the north side of Mt. Goode, showing the approach to the northeast buttress and high camp and emergency bivouac after the accident.

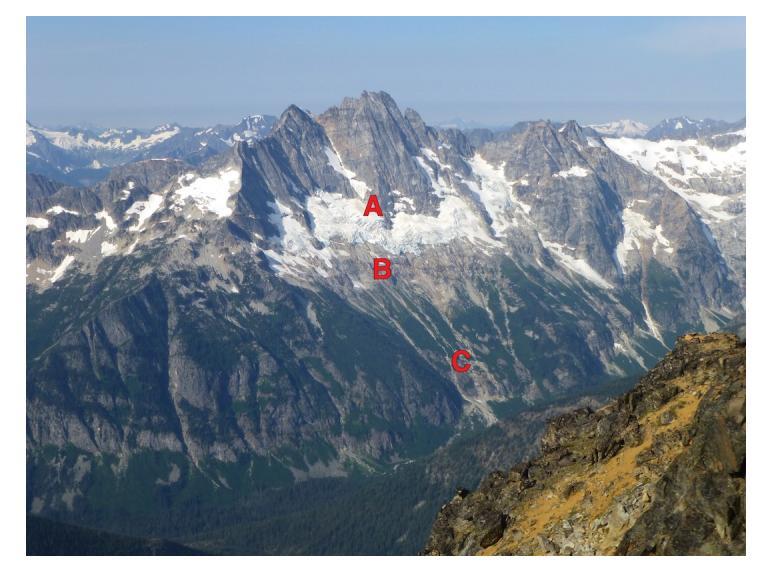
The north side of Mt. Goode, above the Goode Glacier. (A) Site of the accident, where ice fell from the gully above as climbers tried to reach the rock buttress. (B) High camp at 5,700 feet. (C) Emergency bivouac and evacuation site at 4,100 feet.
